Inspection Report

Property Address:
123 John Street
Somewhere NC 90210

Raleigh Inspection Service

Date: 1/21/2016	Time: 08:30 AM	Report ID: JohnStSAMPLE
Property: 123 John Street Somewhere NC 90210	Customer: John Q Buyer	Real Estate Professional: Ron Realtor

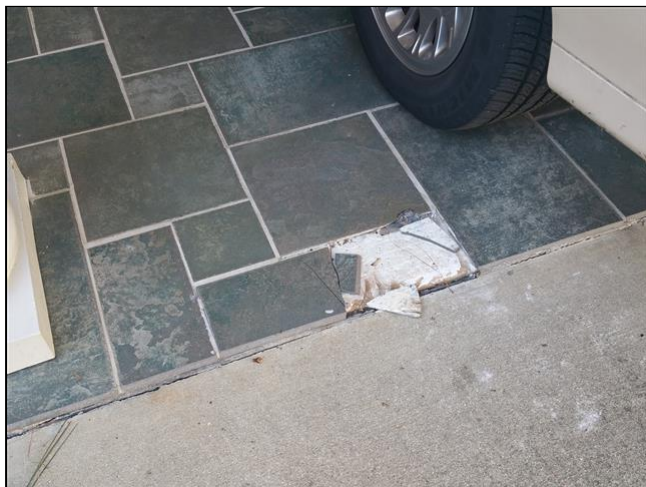
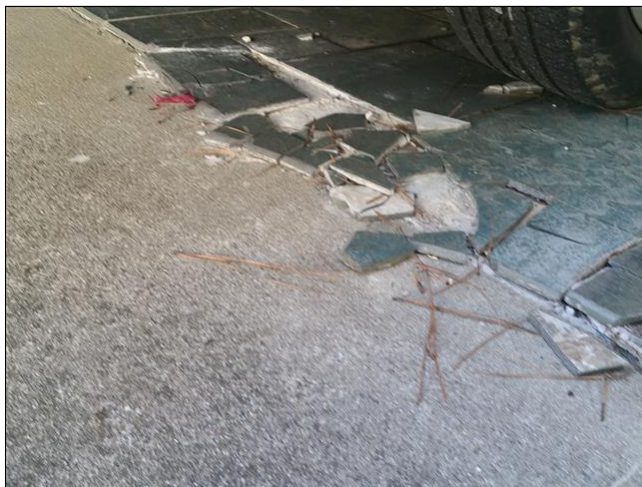
**Repair-** *[location: front porch and rear carport]* The walkway slate tiles are damaged at multiple locations. A qualified contractor should repair.

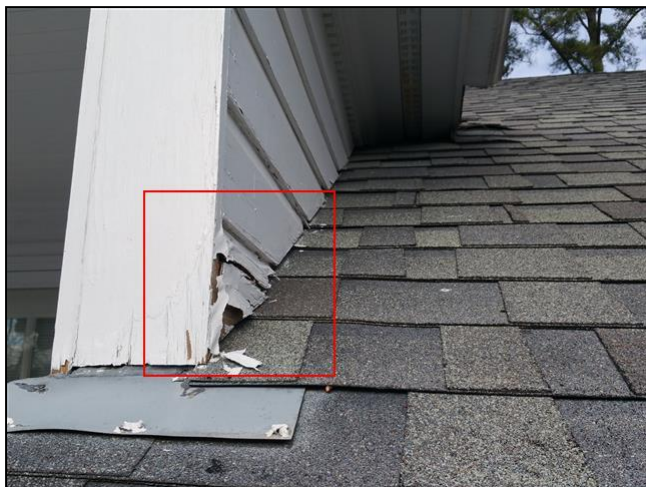
front roof line near porch

- 🔧 (1) **Repair-** Exterior trim and wall cladding deterioration (or damage) is present at several locations. A siding contractor should evaluate all exterior sides of the home and repair as necessary. The inspector has provided photographs where deterioration or damage was found. Photographed areas require immediate repair.

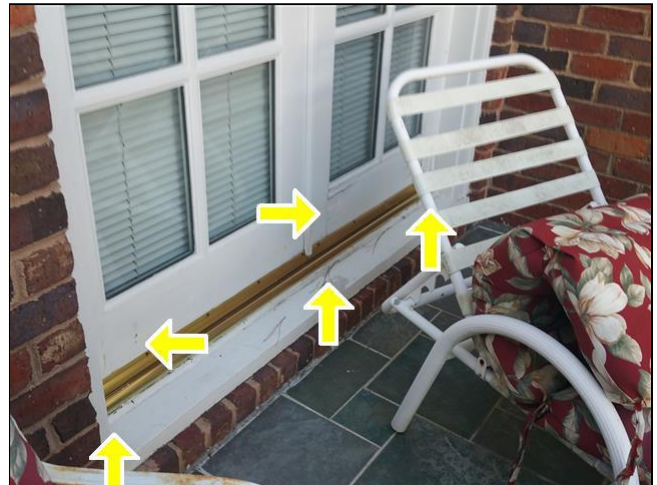
- 🔧 **Repair-** *[location: rear entry door]* The door at the specified location is damaged or deteriorated. A common location for door deterioration is at the bottom of the door. A qualified contractor should examine the door and repair as necessary. Full door replacement may be necessary.

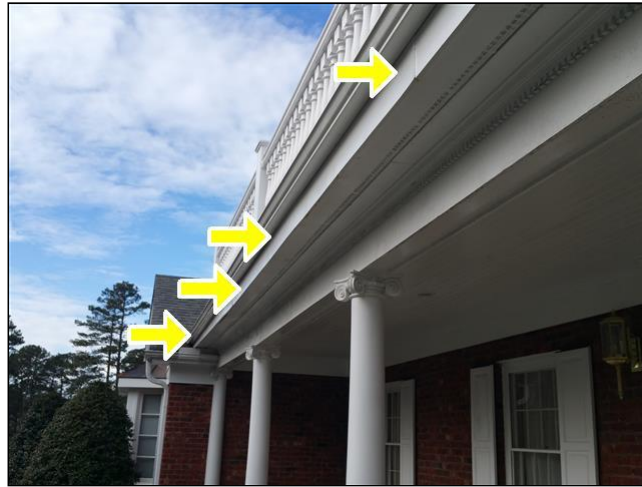
- 🔧 (1) **Repair-** *[location: along soffit at front porch (or patio)]* Rusty nail heads are present on the bottom side of a boxed soffit. This condition generally indicates moisture has intruded at roof covering directly above. Gutters are not functioning properly. Drip edge installation may be necessary. Soffit damage was observed. This roof area above the soffit should be examined by a roofing contractor and repaired where necessary. Licensed general contractor should repair.

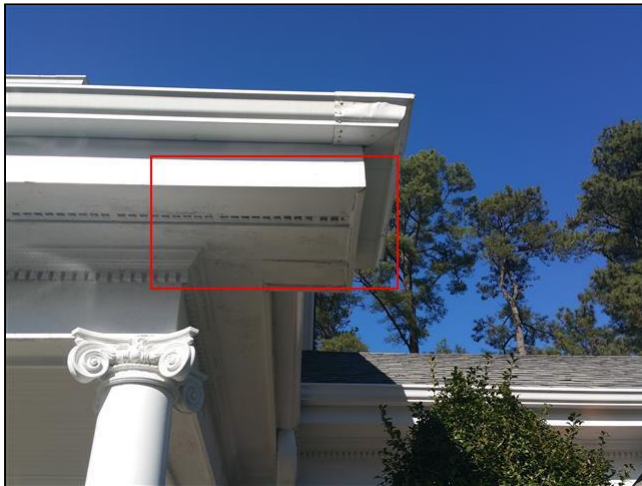
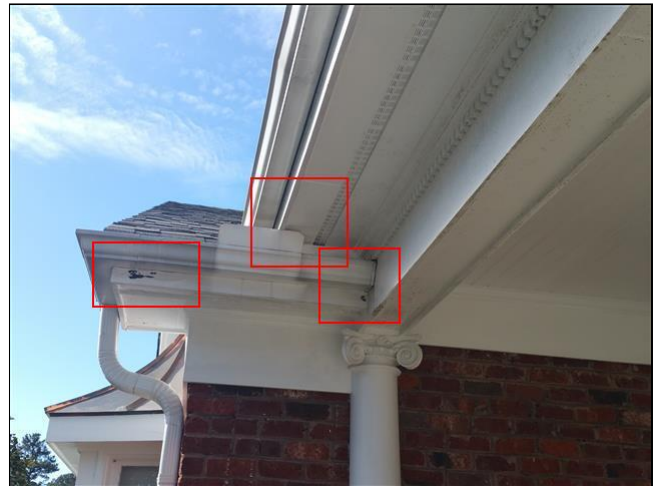
- 🔧 (2) **Repair-** *[location: front porch (or patio)]* The soffit is deteriorated at the specified location. If these type of issues are not repaired, it could lead to moisture intrusion inside the house and other interior framing members. A qualified contractor should determine cause and repair or replace affected wood. It could be necessary to repair leaky roofing above this location.

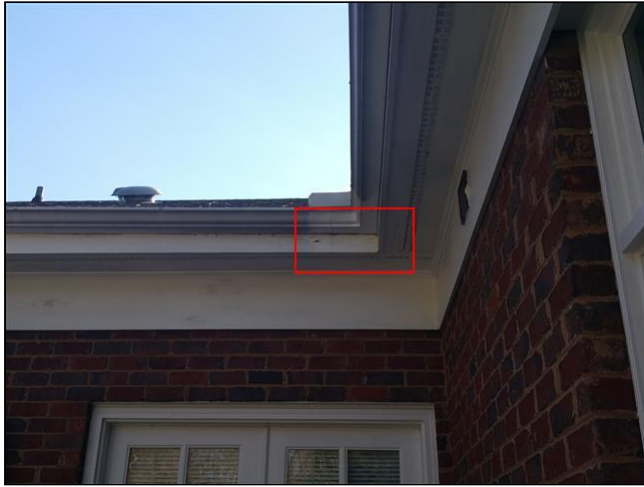
above rear entry

- 🔧 (3) **Repair-** *[location: rear side of home at porch (or patio)]* The soffit is deteriorated at the specified location. If these type of issues are not repaired, it could lead to moisture intrusion inside the house and other interior framing members. A qualified contractor should determine cause and repair or replace affected wood. It could be necessary to repair leaky roofing above this location.

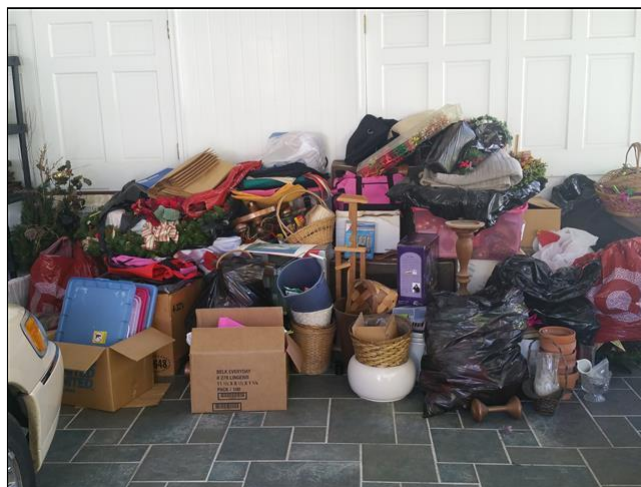
Not Inspected- Furniture was blocking access to exterior doors in master bedroom sun room and exterior storage closet at carport.

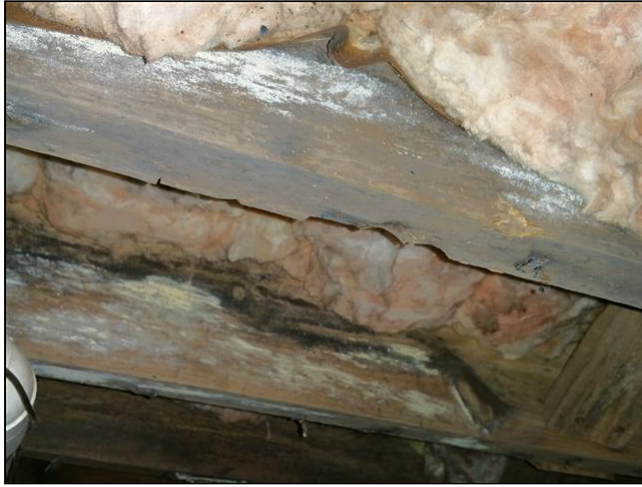
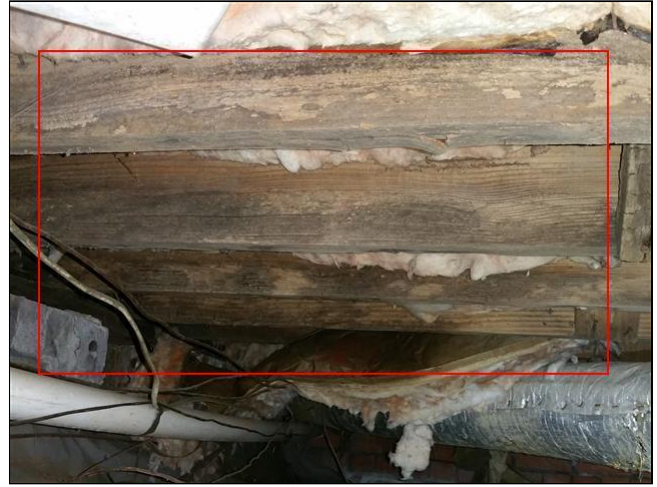
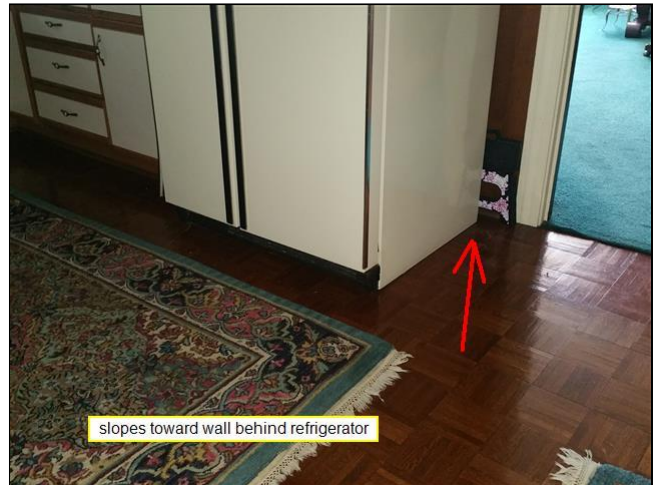
- 🔧 (1) **Repair-** *[location: right crawlspace below kitchen and billiard room]* A section of flooring appears to be sagging with respect to the rest of the floor system. There is evidence that suggest the underfloor area has been exposed to high humidity. The soil was muddy or water logged underneath the vapor barrier. The bottom 1/3 of a floor joist is deteriorated in some areas. Sagging floors were observed along interior spaces. Existing ventilation is poor. Consulting with a ventilation contractor or "closed crawlspace" contractor is recommended. A licensed general contractor should make joist repair per engineers specifications.

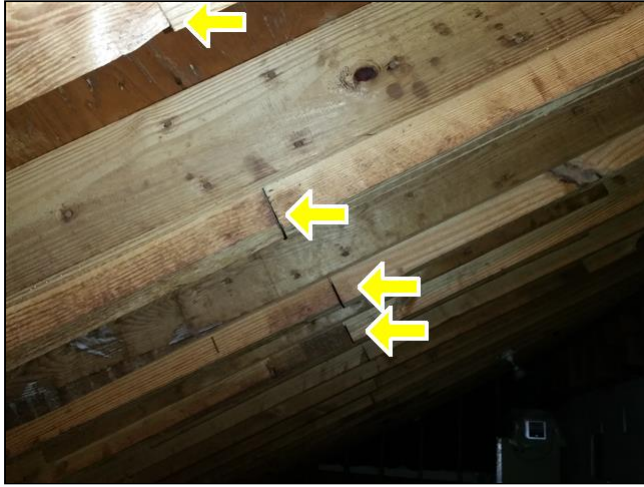
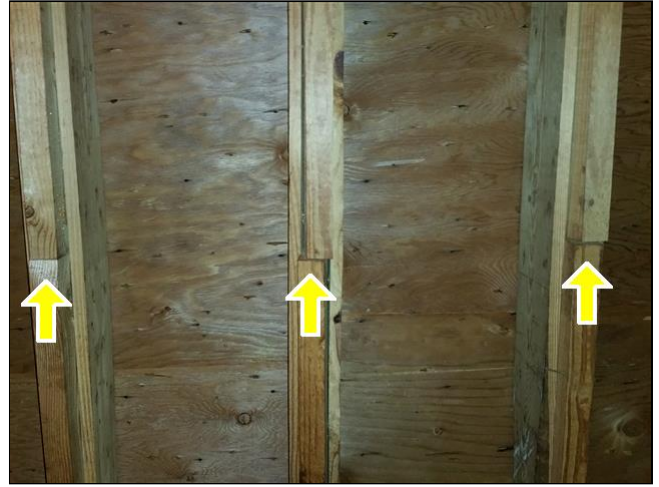
Investigate/Repair [location: area at rear portion of attic space] The rear set of rafters are cut at mid span. A temporary repair has been made. The roof rafter system should be designed and constructed in compliance with the building code. Building standards have changed since this house was originally constructed. Materials used should be spaced, sized, and span according to lumber manufacturers specifications. The inspector identified a location where spacing, sizing, or span may require improvements or reinforcement. A licensed structural engineer should evaluate and make recommendations.

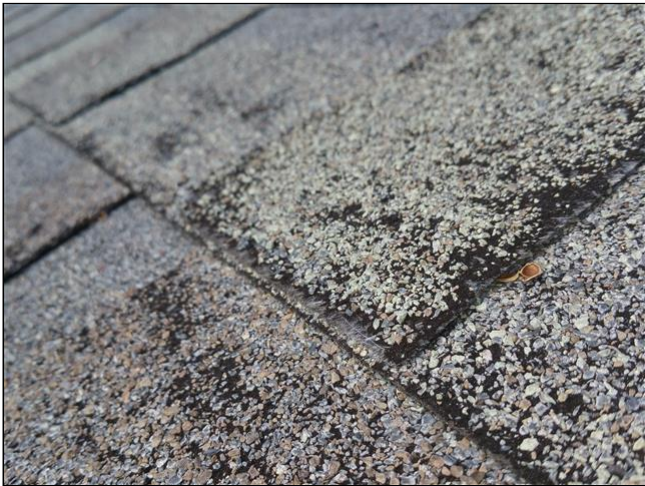
Investigate- The roof covering is a architectural asphalt shingle roof system. Most architectural asphalt shingled roof systems that are properly maintained typically yield 20 years on average. The inspector believes the roof covering **is nearing the end of an average roofing life cycle**. Fiberglass mat exposure was observed. Mat exposure and granular loss is indicative of an aging roof covering. The client should consider obtaining opinion from a roofing contractor.

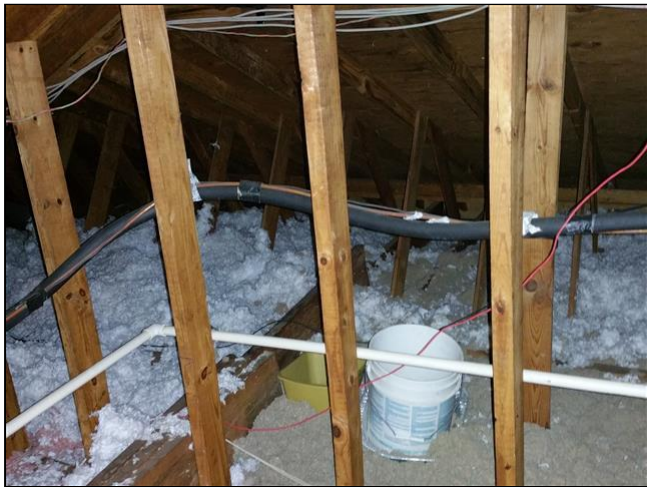
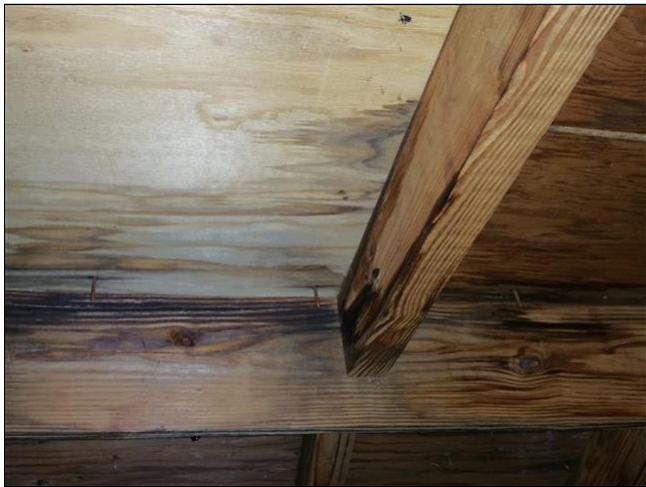
Investigate- *[location: along rear right corner roof surface]* While inspecting the attic space, the inspector observed water stains at or near a pipe penetration. This condition generally indicates that the pipe and/or flue penetrations need additional sealant or flashing maintenance. The inspector is unable to determine, with certainty, if the stains are from past or present leakage. A roofing contractor should provide opinion.

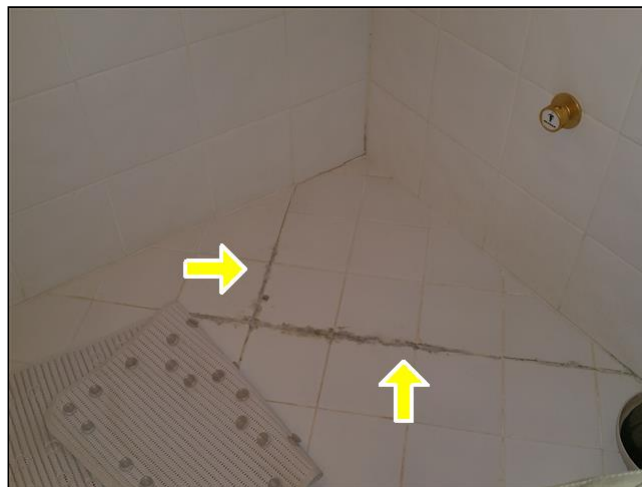
- 🔧 (2) **Repair-** *[location: master bathroom]* The ceramic tile near the tub/shower is severely cracked and has been temporarily repaired. Additional repairs are necessary. Performing shower pan test is recommended.

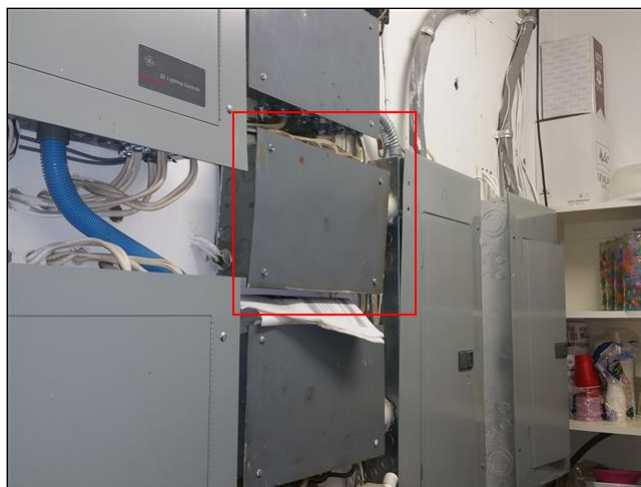
- 🔍 (1) **Investigate-** [location: all distribution boxes] The cover of the electrical panel was unusually warm. This condition generally indicates a conductor inside the panel box is arcing. The inspector did not remove the electrical panel cover because of safety concerns. A licensed electrician should evaluate.

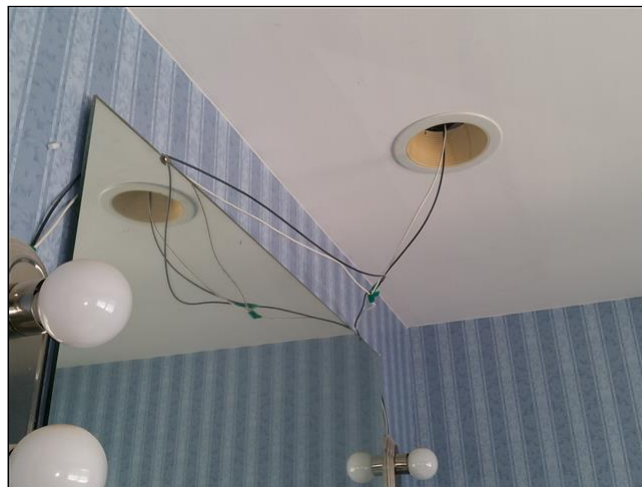
- 🔧 (1) **Repair-** *[location: second floor guest bathroom]* An extension cord is used to power an permanently installed electrical device. A licensed electrical contractor should connect the device with a permanent branch circuit.

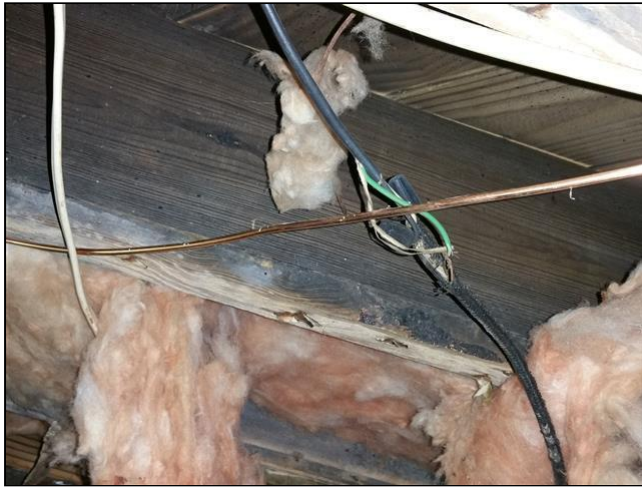
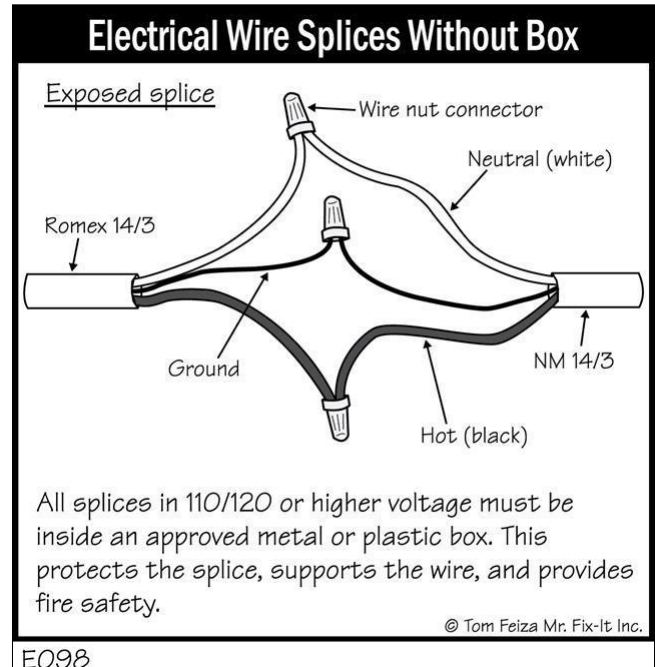
- 🔧 (2) **Repair-** *[location: rear right crawlspace]* Exposed electrical conductors (or wire splices) were observed. The inspector did not test to determine if wires are abandoned or flowing live current. All wire splices should be placed inside a junction box and covered with a solid junction box plate. The inspector noted at least one improper wire splice. All exposed conductors should be placed inside a mounted electrical box that is covered with a solid plate. Exposed hot electrical wires can create a serious fire and safety hazard. A licensed electrical contractor should repair.

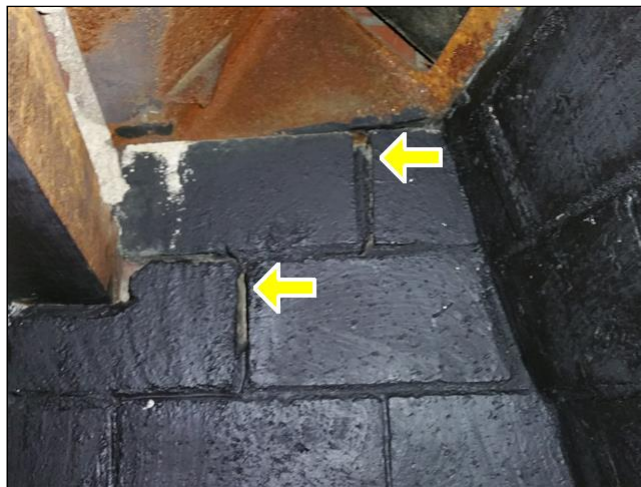
(1) **Investigate-** A void or gap was observed between the brick joints inside the formal living room firebox. This condition commonly occurs where the firebox transitions to the clay flue liner. This condition should be checked by a licensed chimney sweep before using the masonry fireplace. Repairs could be necessary.

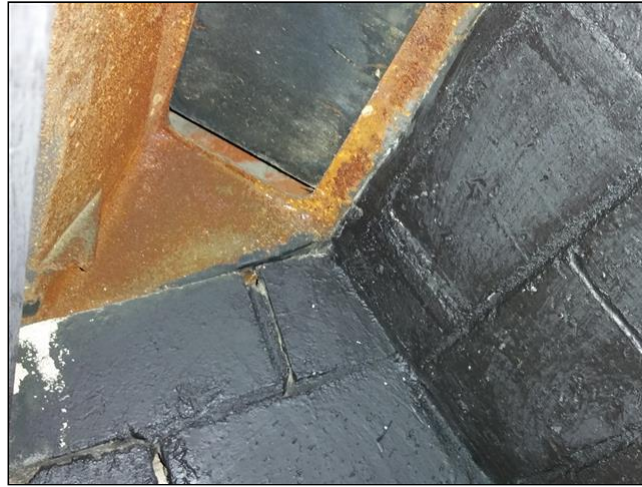
- 🔍 (2) **Investigate/Repair-** *[location: formal living room firebox]* While inspecting the fire box, the inspector observed stains that could indicate previous water intrusion from the chimney cap. This condition generally indicates that the pipe and/or flue penetrations need additional sealant or flashing maintenance. Contractor should investigate and repair as necessary.

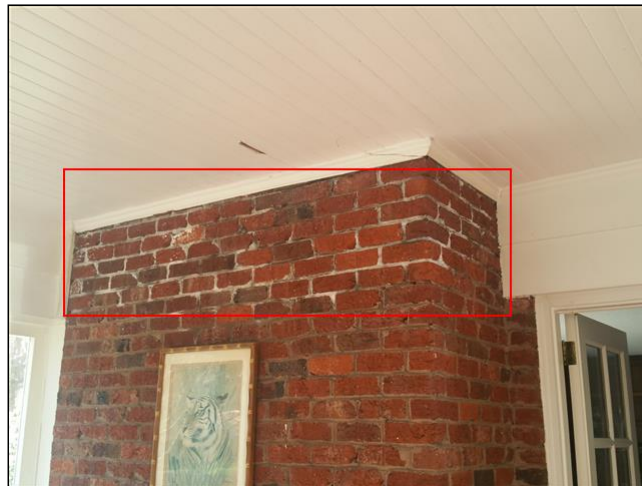
- 🔧 (3) **Investigate/Repair-** *[location: right porch (or patio)]* The inspector observed efflorescence or white mineral deposits that could indicate previous water intrusion from the chimney cap. This condition generally indicates that the pipe and/or flue penetrations need additional sealant or flashing maintenance. Contractor should investigate and repair as necessary.

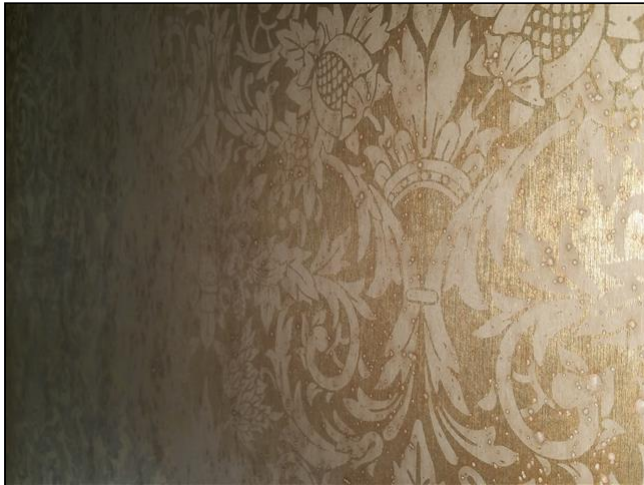
- 🔍 **Investigate-** Evidence of high humidity was observed in the master bathroom. Mildew was observed on the walls. This condition could indicate a cooling system is not sized properly. The general rule of thumb is that every "ton" of cooling capacity should properly cool 600-800 square feet of living space. A variety of factors can influence a cooling load calculation. The inspector recommends consulting with a licensed HVAC contractor to determine if the outdoor component of the master bedroom air conditioning system is properly sized. Cooling load calculation may be necessary.

humidity evidence/mold on wall

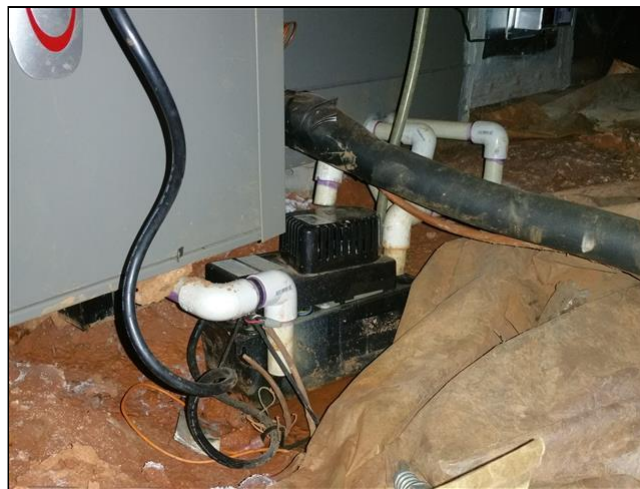
- 🔧 (1) **Repair-** *[location: unit in the center crawlspace]* The condensation drain line is not functioning as intended. Currently, all excess condensation is draining into crawlspace. It appears the condensate pump/drain was never installed correctly. If left uncorrected, this defect could cause excessive moisture levels in the crawlspace. The inspector recommends consulting a licensed HVAC contractor for repair.

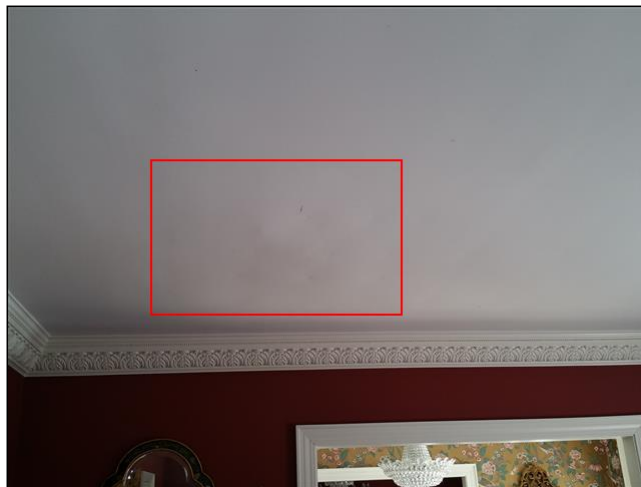
- 🔍 (1) **Investigate/Repair** [*location: formal living room below guest bathroom*] The interior ceiling shows stains which could indicate a plumbing leak. The inspector suspects staining is from a recent event. A licensed plumbing contractor should repair.

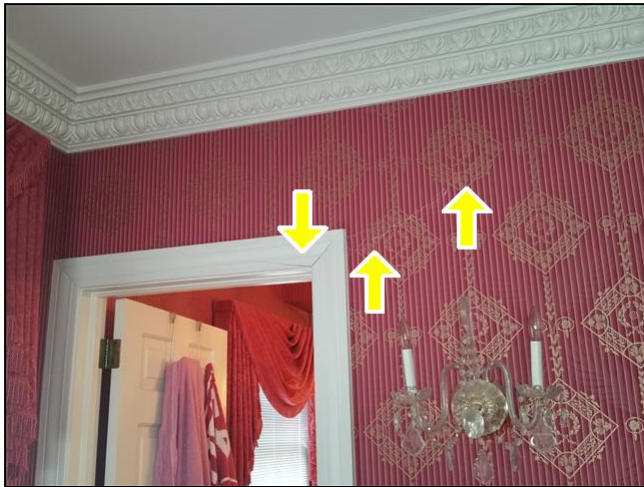
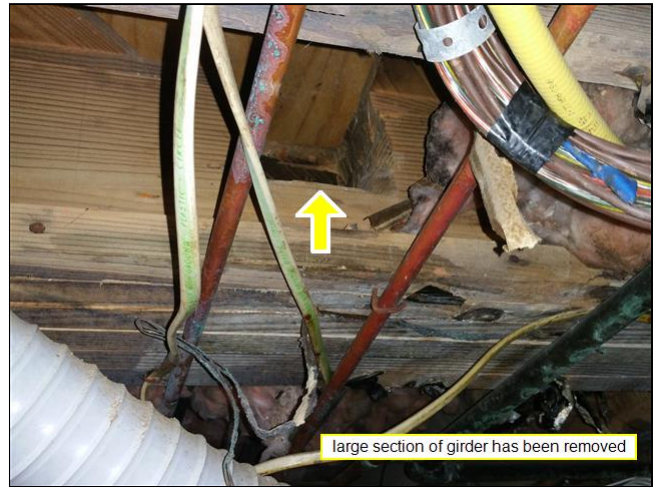
🔧 (2) **Investigate/Repair** [*location: first floor left guest bathroom*] A wall crack was identified that could be related to a structural issue. A structural defect identified in the crawlspace could be contributing to the wall crack. A licensed structural engineer should review and make appropriate recommendations.

girder over notched

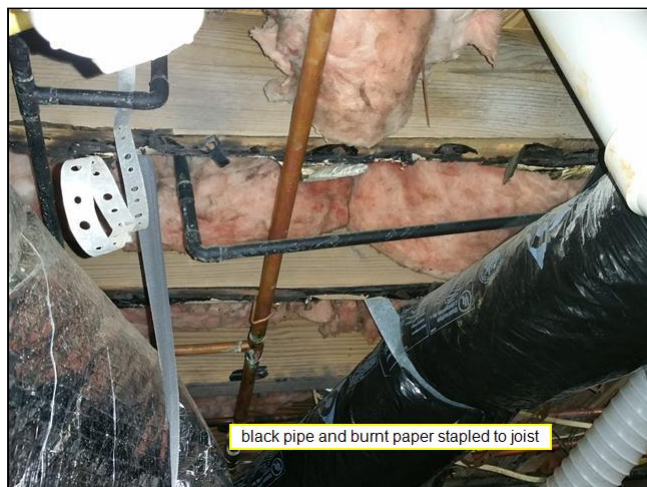
- 🔍 (4) **Investigate-** *[location: crawlspace]* Soot stains were observed at the specified location. This could indicate a fire has occurred at the subject property. Framing members are still solid. Further investigation is necessary to gain historical prospective about the property. Consulting the current owner and an insurance provider is recommended.

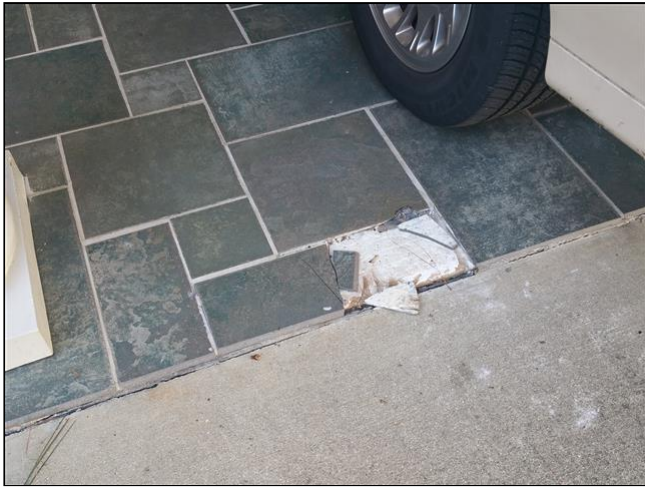
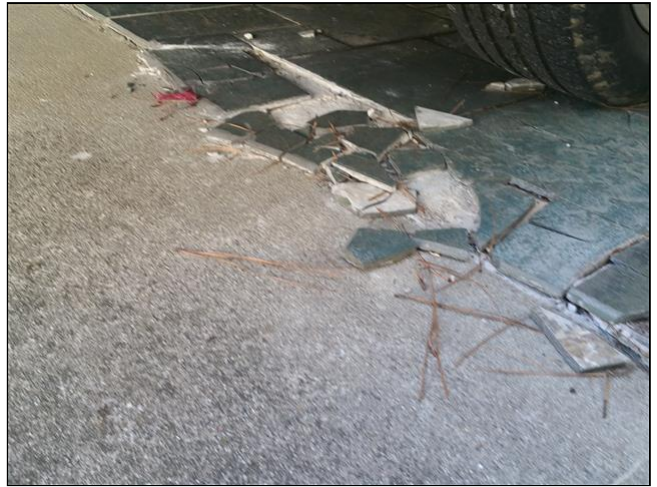
1. **Repair-** [location: front porch and rear carport] The walkway slate tiles are damaged at multiple locations. A qualified contractor should repair.

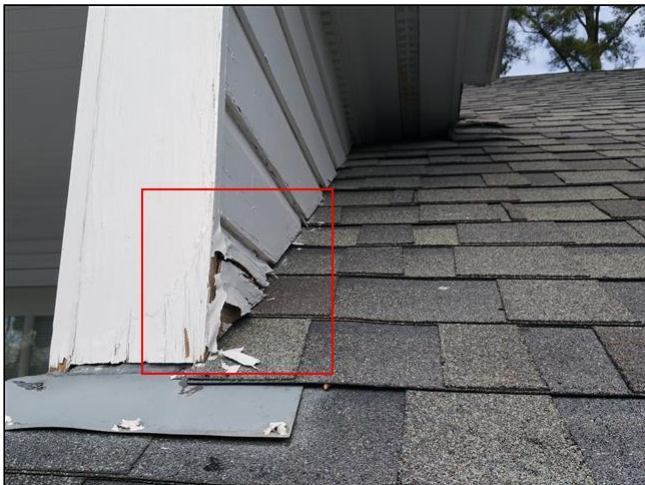
front roof line near porch

2. (1) **Repair-** Exterior trim and wall cladding deterioration (or damage) is present at several locations. A siding contractor should evaluate all exterior sides of the home and repair as necessary. The inspector has provided photographs where deterioration or damage was found. Photographed areas require immediate repair.

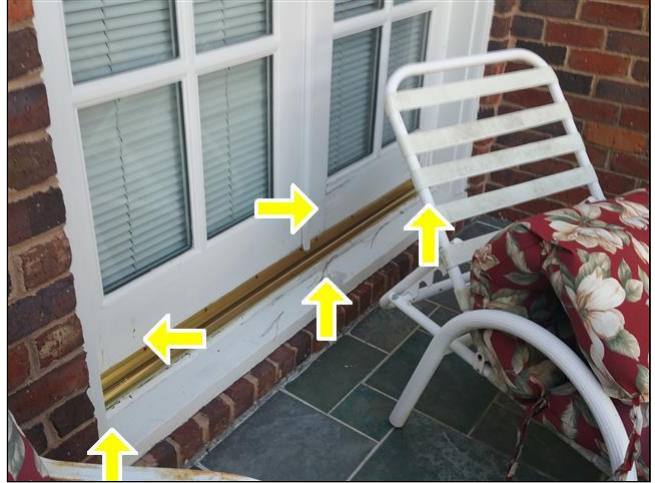
- 4. Repair-** *[location: rear entry door]* The door at the specified location is damaged or deteriorated. A common location for door deterioration is at the bottom of the door. A qualified contractor should examine the door and repair as necessary. Full door replacement may be necessary.

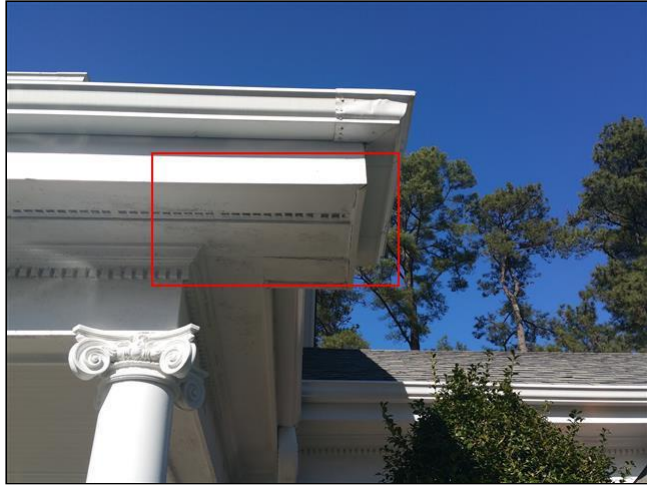
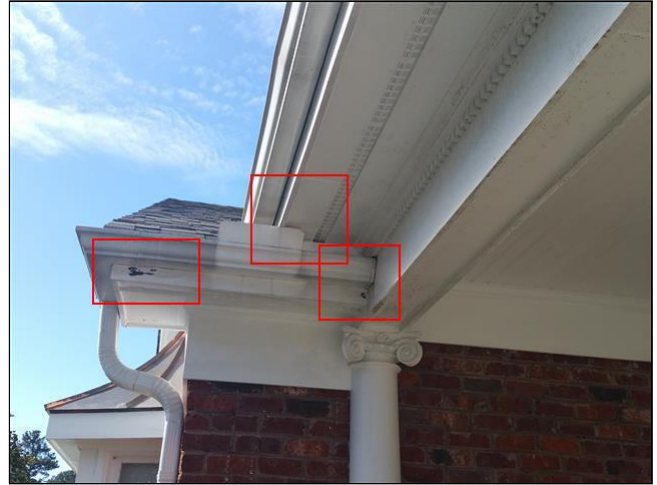
- 6. (2) Repair-** *[location: front porch (or patio)]* The soffit is deteriorated at the specified location. If these type of issues are not repaired, it could lead to moisture intrusion inside the house and other interior framing members. A qualified contractor should determine cause and repair or replace affected wood. It could be necessary to repair leaky roofing above this location.

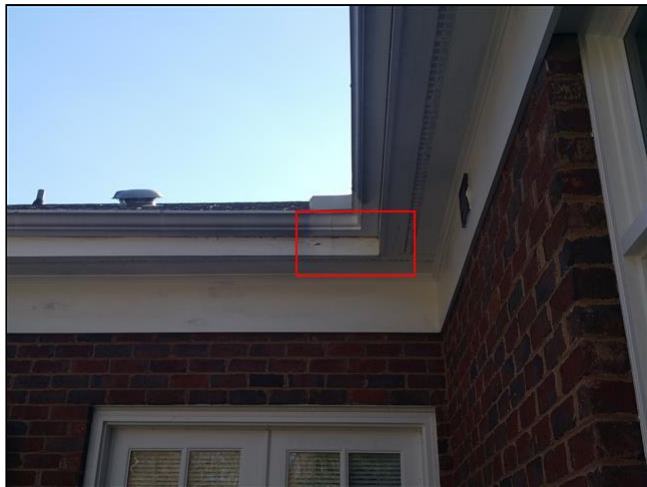
above rear entry

7. (3) **Repair-** *[location: rear side of home at porch (or patio)]* The soffit is deteriorated at the specified location. If these type of issues are not repaired, it could lead to moisture intrusion inside the house and other interior framing members. A qualified contractor should determine cause and repair or replace affected wood. It could be necessary to repair leaky roofing above this location.

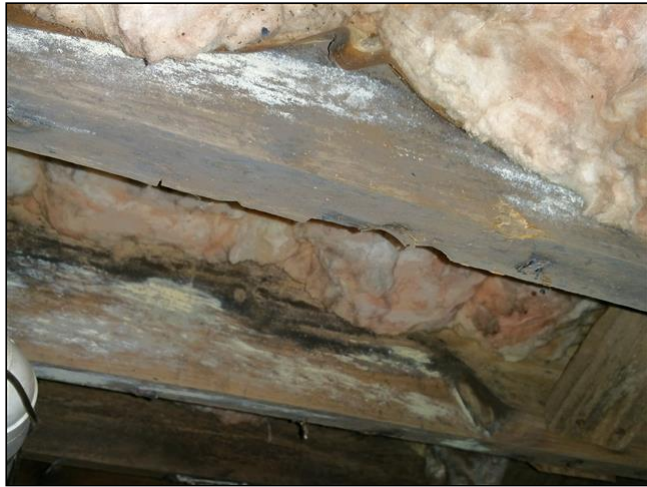
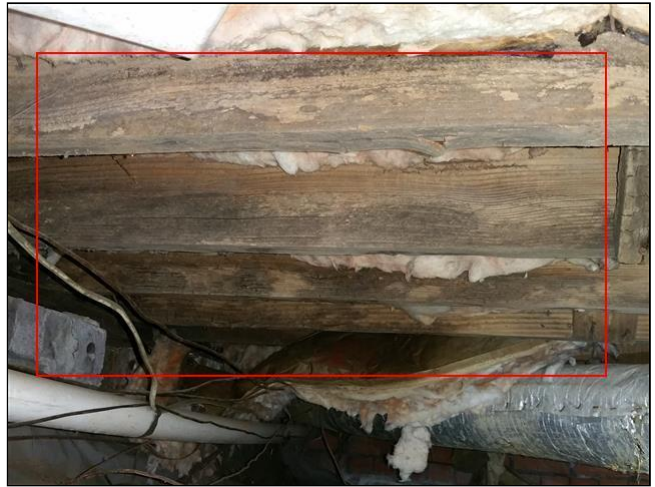
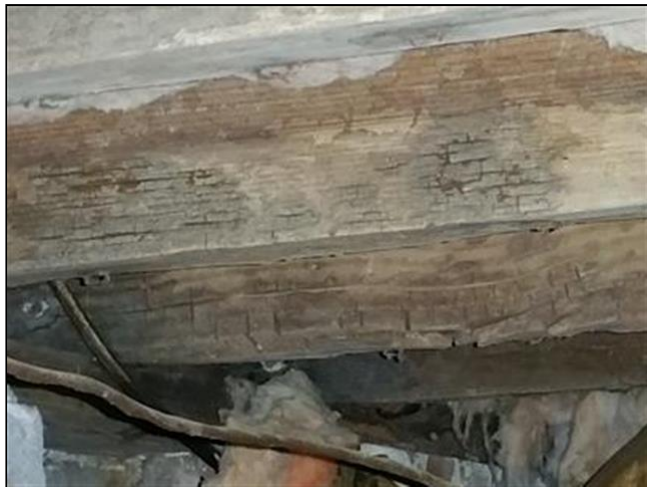
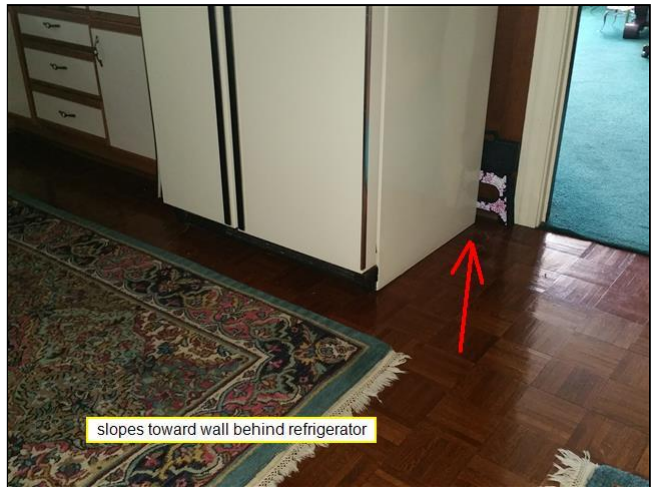
8. (1) **Repair-** *[location: right crawlspace below kitchen and billiard room]* A section of flooring appears to be sagging with respect to the rest of the floor system. There is evidence that suggest the underfloor area has been exposed to high humidity. The soil was muddy or water logged underneath the vapor barrier. The bottom 1/3 of a floor joist is deteriorated in some areas. Sagging floors were observed along interior spaces. Existing ventilation is poor. Consulting with a ventilation contractor or "closed crawlspace" contractor is recommended. A licensed general contractor should make joist repair per engineers specifications.

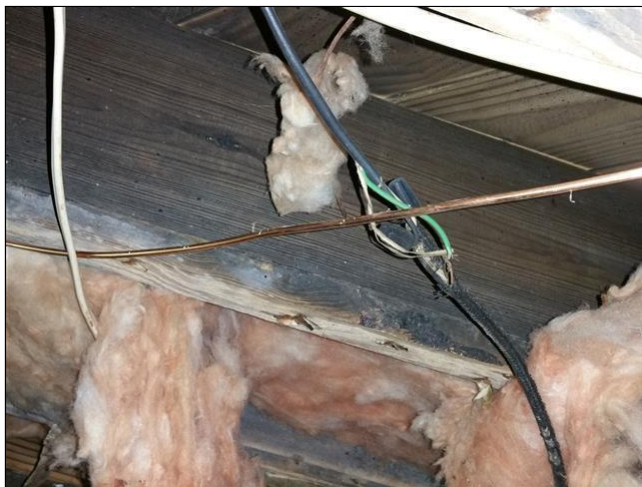
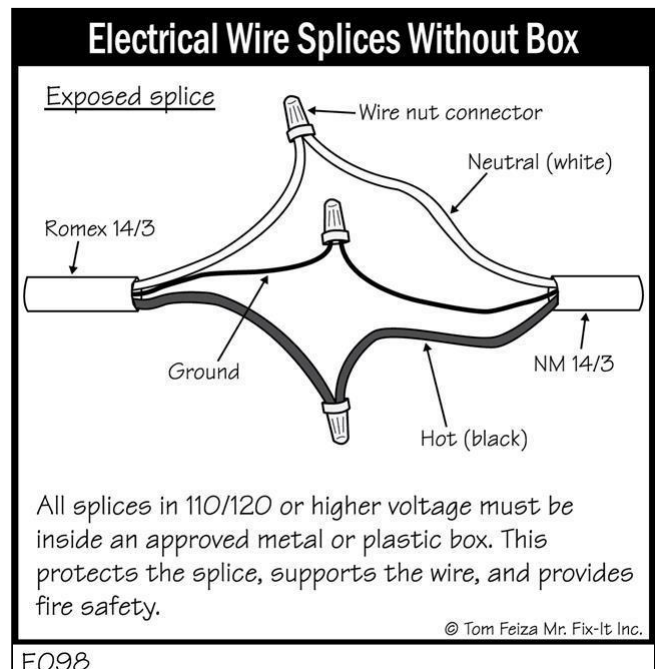
23. (2) **Repair-** *[location: rear right crawlspace]* Exposed electrical conductors (or wire splices) were observed. The inspector did not test to determine if wires are abandoned or flowing live current. All wire splices should be placed inside a junction box and covered with a solid junction box plate. The inspector noted at least one improper wire splice. All exposed conductors should be placed inside a mounted electrical box that is covered with a solid plate. Exposed hot electrical wires can create a serious fire and safety hazard. A licensed electrical contractor should repair.

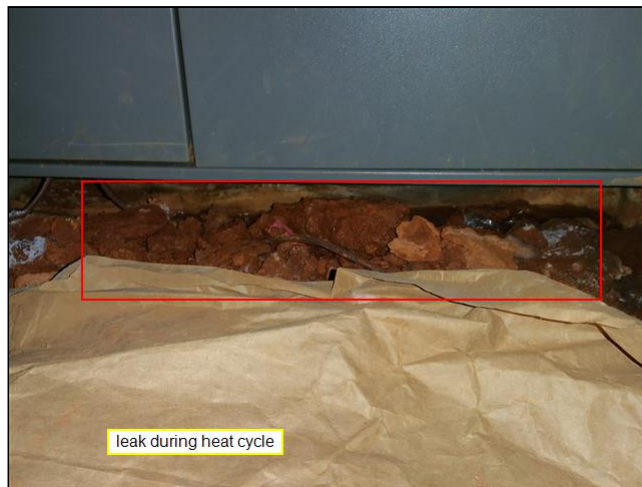
30. (2) **Repair-** *[location: center crawlspace]* The combustion condensate drain line originating at the furnace does not drain all excess condensation properly. There is evidence that suggest the line has leaked moisture recently.

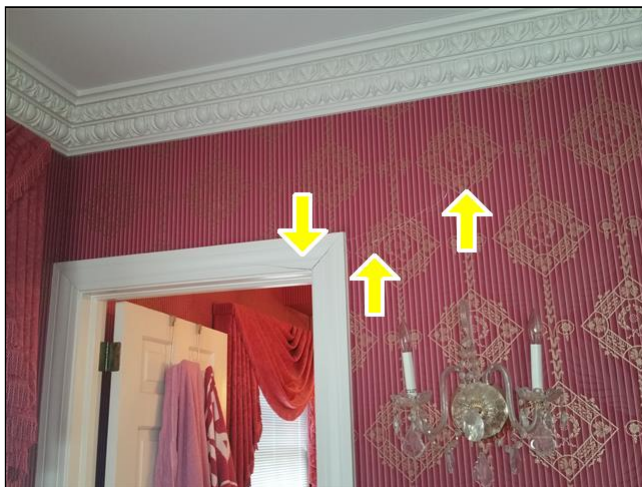
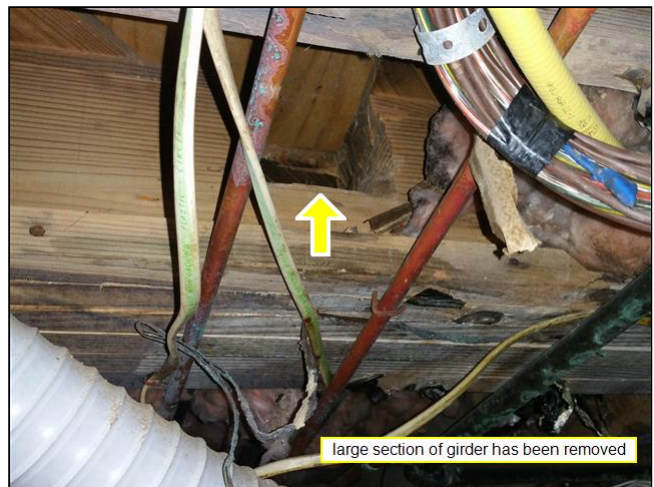
girder over notched

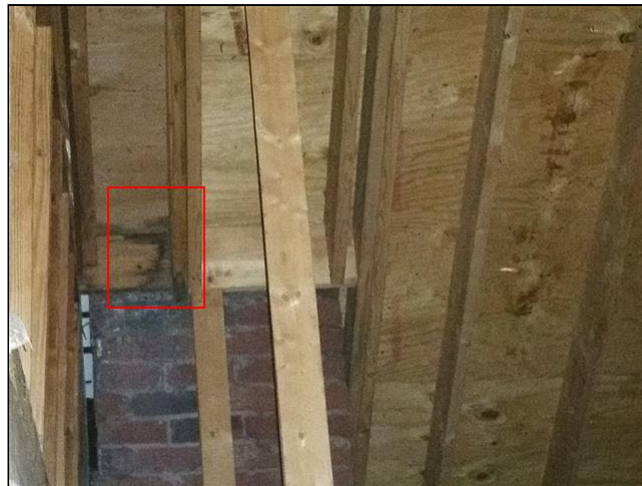
- 42. (2) Investigate-** Water intrusion stains were observed on the surrounding area where the chimney joins the roof sheathing. The inspector is unable to determine if this is recent water intrusion. A roofing contractor should provide opinion.

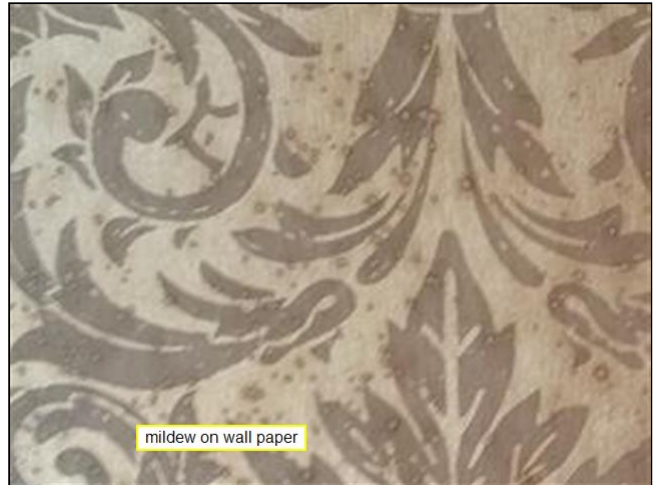
humidity evidence/mold on wall

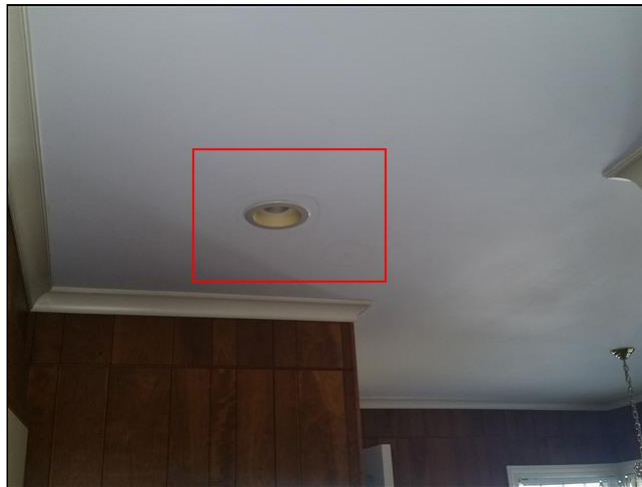
- 56. (3) Investigate-** *[location: kitchen]* The interior ceiling shows stains which could indicate exterior water intrusion or a leaking or sweating condensation line. The inspector is unable to determine with certainty if the stain is the result of a past incident or present problem. Current owner should provide more information. A qualified contractor should provide opinion.

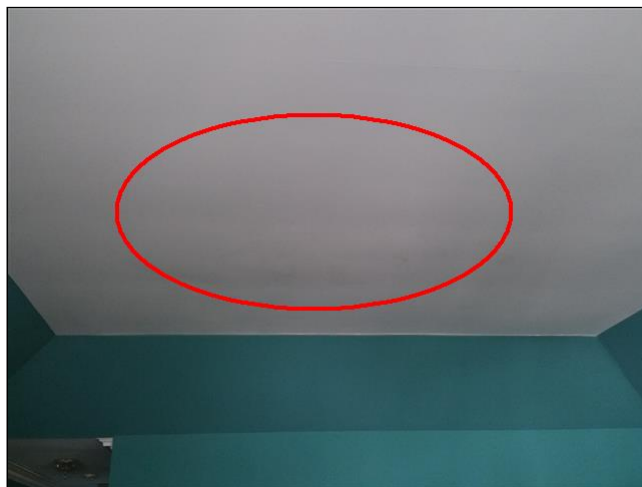
- 57. (4) Investigate-** *[location: master bedroom]* The interior ceiling shows stains which could indicate a roof leak. The inspector is unable to determine with certainty if the stain is the result of a past incident or present problem. Current owner should provide more information. A roofing contractor should provide opinion.
