PROPERTY INSPECTION REPORT

Concerning: 123 John Street
Wake Forest, NC 27587

Inspection Date: 1/29/2007

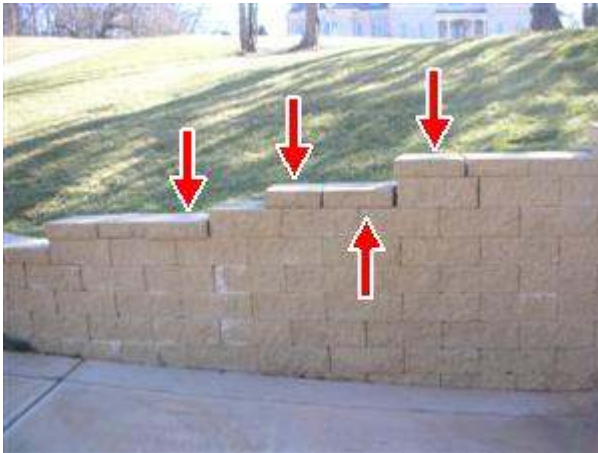
B. Picture 1

(1) **SAFETY RECOMMENDATION-** At least one section of the header block pavers were installed in a dry stacked fashion at the retaining wall on the right side of the home (facing front). This method of installation creates a potential safety and trip hazard for children playing around this area. The inspector recommends permanently securing these header blocks to the main section of the wall.

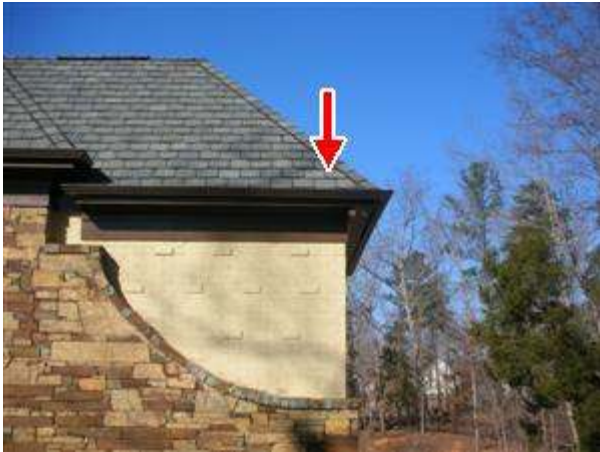
C. Picture 1

(1) At least one section of the roof covering has hairline cracks in the shingles. This is possibly from a manufacturer defect. No other signs indicated water penetration into the roof structure at this area of roof. The inspector was unable to determine if this defect will leak. (See photo note)

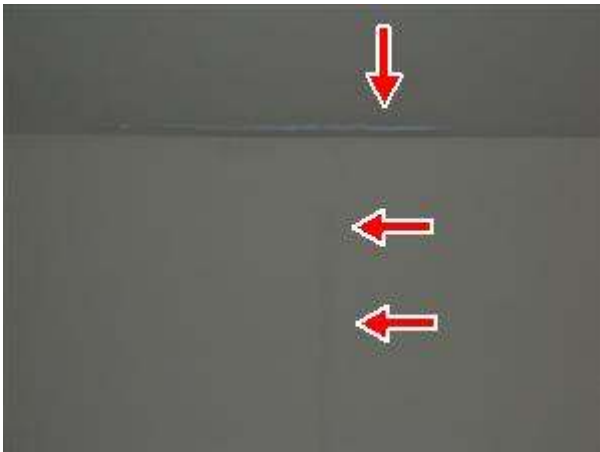
E. Picture 1

(1) The sheetrock on the wall or ceiling shows wet stains indicating moisture intrusion has occurred. The inspector recommends consulting with the seller for more information about this area. Due to recent weather conditions, the inspector is unable to determine with certainty if a leak still exists. Further evaluation is required by a qualified contractor. The area(s) of concern is located at the following locations:

1. above rear entry door at main level (kitchen and living room)

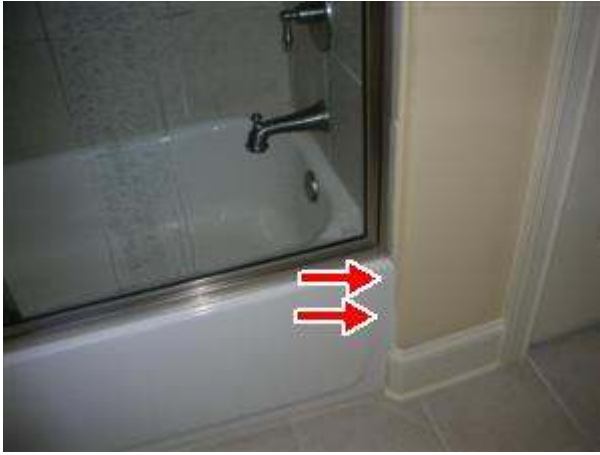
E. Picture 2 third floor bathroom

(2) The inspector recommends caulking around all tub areas to prevent moisture intrusion. (See photo note)

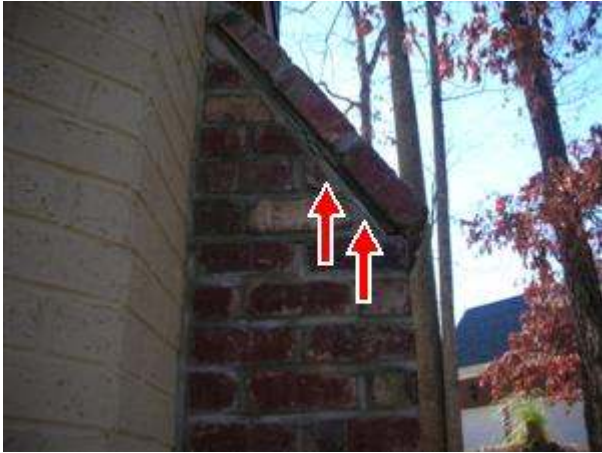
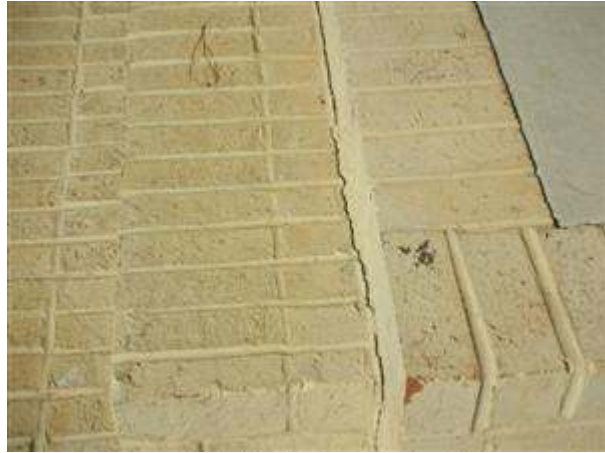
F. Picture 1

The rear and sides of the home reveals at least one common crack along the mortar joints. It is not uncommon for a house to experience some natural foundation and wall movement over time. The inspector recommends re-pointing all affected mortar joints with mortar mix. (see photo note)

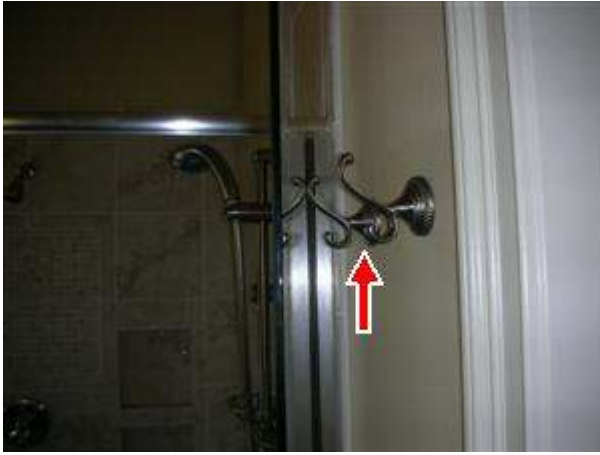
H. Picture 1 master bathroom glass door

- 🏠 (3) **SAFETY RECOMMENDATION-** The inspector did verify that the glass door is safety tempered, however it is still recommended that all objects that could possibly shatter the glass door be removed from the doors natural swing pattern. (see photo note)

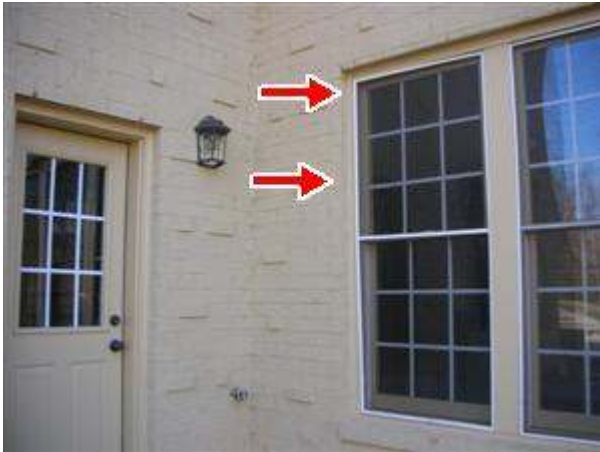
I. Picture 1 screen loose

(1) The window screen is loose at the rear of home. This is a maintenance issue and is for your information. (See photo note)

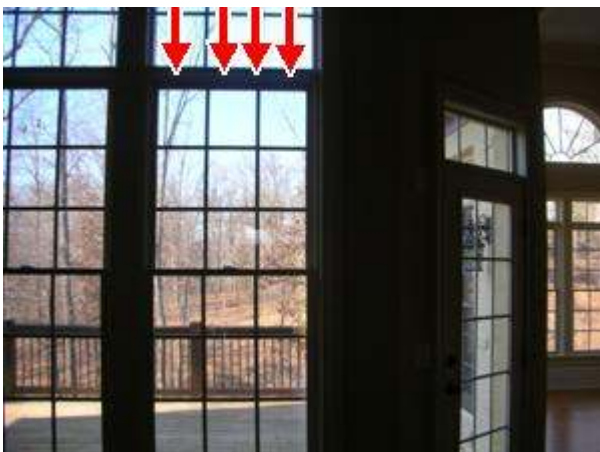
I. Picture 2

1. Dining Room is stuck in the closed position
2. Top sash falls when the window lock moves to the unlocked position (see photo note)
3. finished attic window is stuck in the closed position

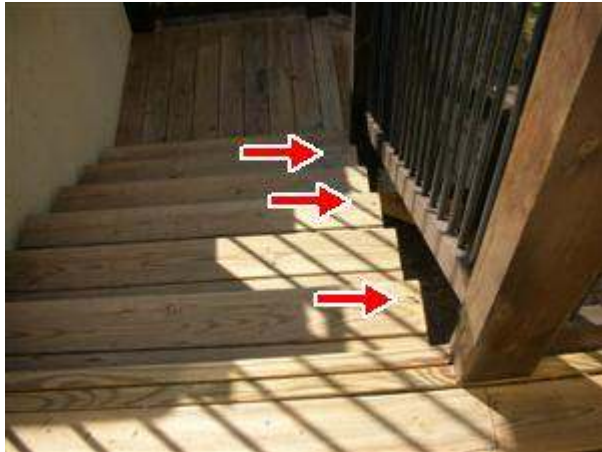
K. Picture 1

(3) Wood stairs at the left side of the home had several nail pops. (See photo notes)

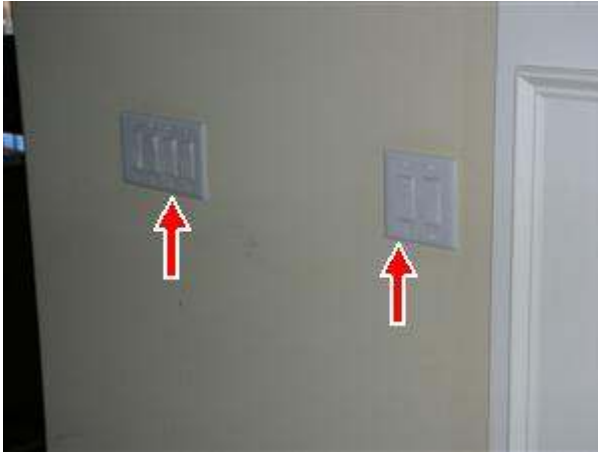
C. Picture 1

1. one switch at the guest bedroom on the main level at left side of home
2. one switch on the foyer switch panel (see photo notes)
3. one switch on the master bedroom switch panel
4. fixture above bathroom sink in master bathroom
5. all receptacles and lights on the left side of the home at the third floor need to be checked by an electrician. (the inspector believes this issue is directly related to the tripped panel breaker)

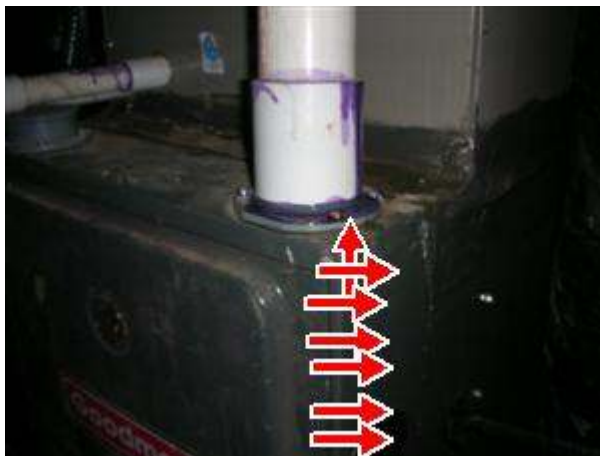
A. Picture 1 water running down furnace

Excessive condensation was noted at the exhaust flue pipe on the furnace unit. This condensation will cause damage to the unit if not repaired. The inspector recommends consulting with a HVAC contractor for repair.

Specifically, this dysfunction occurred on furnace system labeled "UNIT #3" (see photo note)

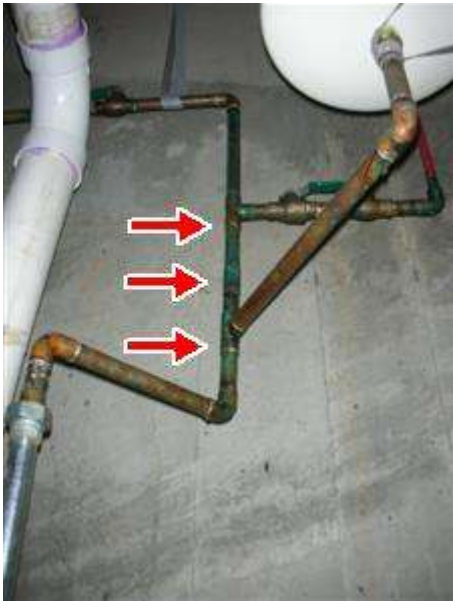
C. Picture 1

(1) The water heater shows signs of leaking at hot supply outlet. A qualified licensed plumber should repair or correct as needed. (see photo note)

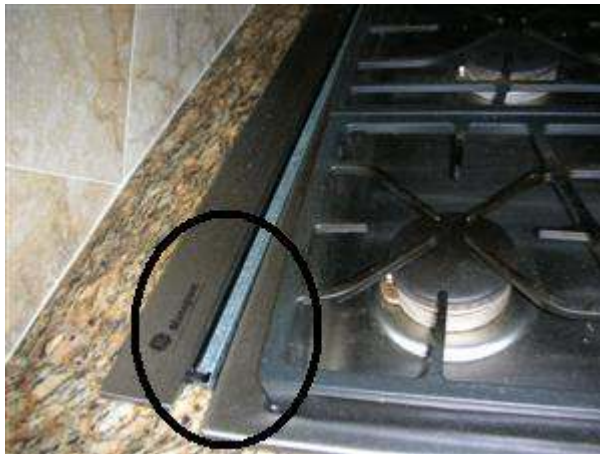
D. Picture 1

The cooktop in the kitchen appears to be skewed. (see photo notes)

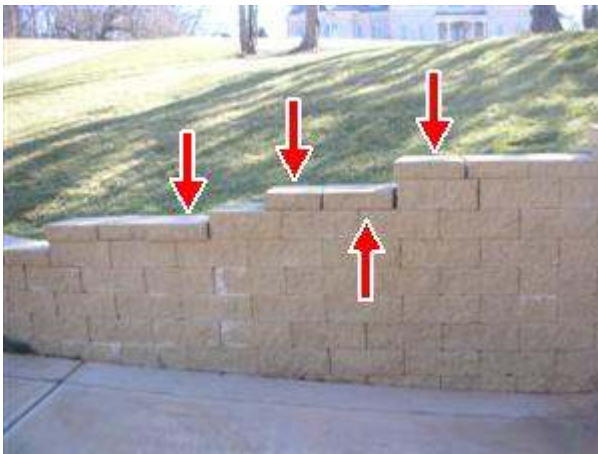
B. Picture 1

(1) **SAFETY RECOMMENDATION**- At least one section of the header block pavers were installed in a dry stacked fashion at the retaining wall on the right side of the home(facing front). This method of installation creates a potential safety and trip hazard for children playing around this area. The inspector recommends permanently securing these header blocks to the main section of the wall.

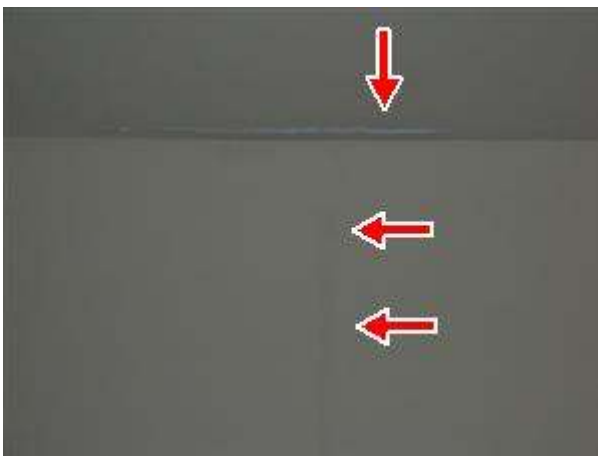
E. Picture 1

(1) The sheetrock on the wall or ceiling shows wet stains indicating moisture intrusion has occurred. The inspector recommends consulting with the seller for more information about this area. Due to recent weather conditions, the inspector is unable to determine with certainty if a leak still exists. Further evaluation is required by a qualified contractor. The area(s) of concern is located at the following locations:

1. above rear entry door at main level (kitchen and living room)

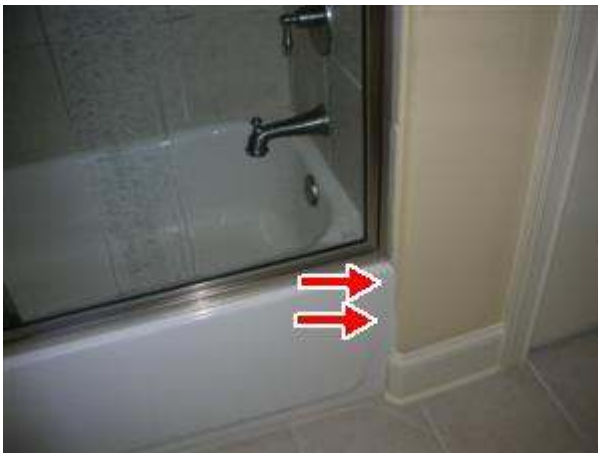
E. Picture 2 third floor bathroom

(2) The inspector recommends caulking around all tub areas to prevent moisture intrusion. (See photo note)

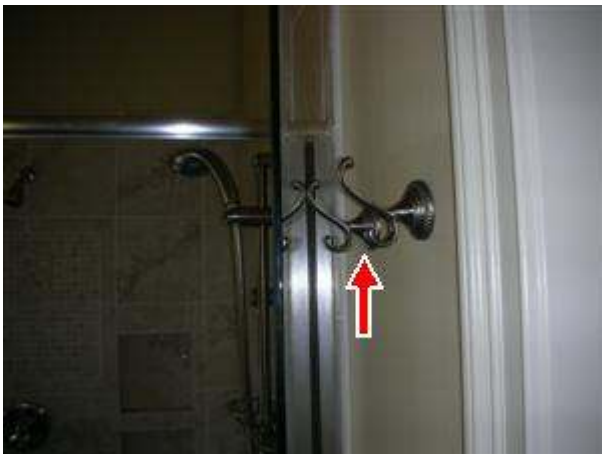
H. Picture 1 master bathroom glass door

🏠 (3) **SAFETY RECOMMENDATION**- The inspector did verify that the glass door is safety tempered, however it is still recommended that all objects that could possibly shatter the glass door be removed from the doors natural swing pattern. (see photo note)

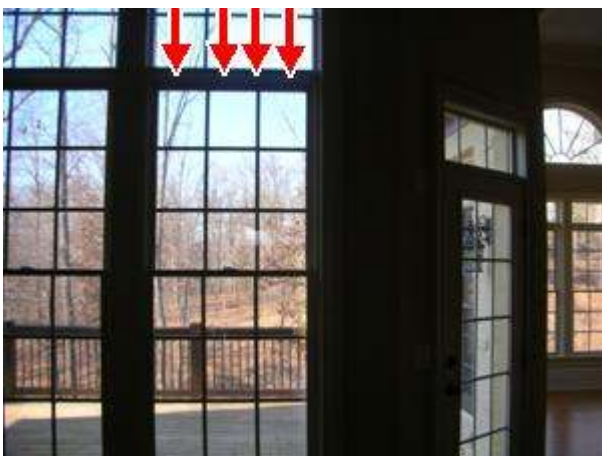
I. Picture 2

1. Dining Room is stuck in the closed position
2. Top sash falls when the window lock moves to the unlocked position (see photo note)
3. finished attic window is stuck in the closed position

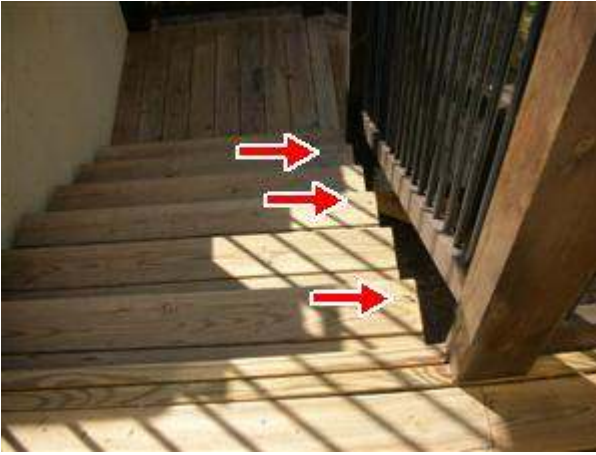
K. Picture 1

🏠 (3) Wood stairs at the left side of the home had several nail pops. (See photo notes)

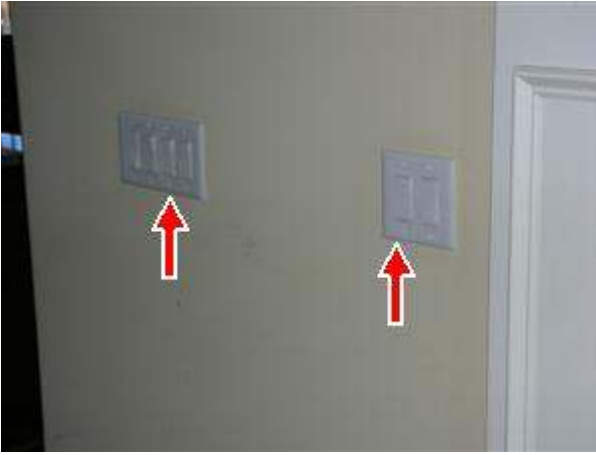
C. Picture 1

1. one switch at the guest bedroom on the main level at left side of home
2. one switch on the foyer switch panel (see photo notes)
3. one switch on the master bedroom switch panel
4. fixture above bathroom sink in master bathroom
5. all receptacles and lights on the left side of the home at the third floor need to be checked by an electrician. (the inspector believes this issue is directly related to the tripped panel breaker)

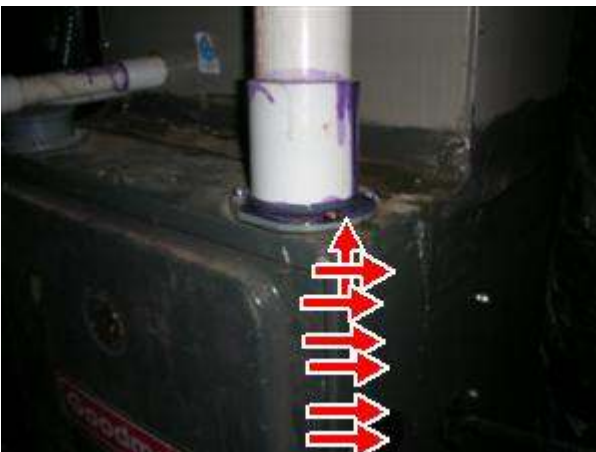
A. Picture 1 water running down furnace

Excessive condensation was noted at the exhaust flue pipe on the furnace unit. This condensation will cause damage to the unit if not repaired. The inspector recommends consulting with a HVAC contractor for repair.

Specifically, this dysfunction occurred on furnace system labeled "UNIT #3" (see photo note)

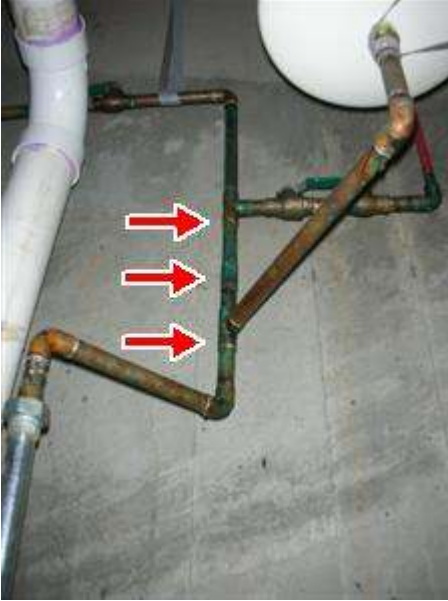
C. Picture 1

🏠 (1) The water heater shows signs of leaking at hot supply outlet. A qualified licensed plumber should repair or correct as needed. (see photo note)

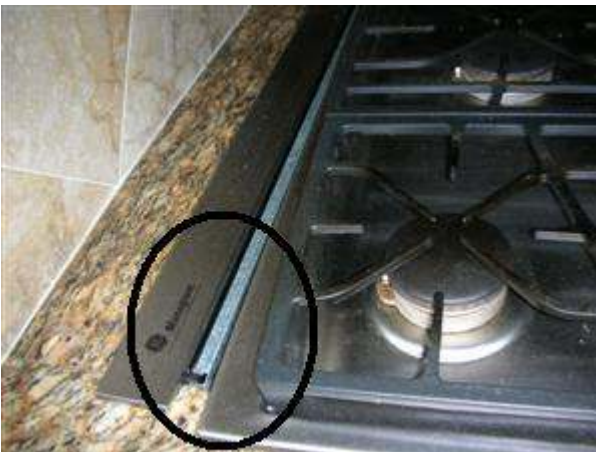
D. Picture 1

🏠 The cooktop in the kitchen appears to be skewed. (see photo notes)
