**RALEIGH
INSPECTION
SERVICE****PROPERTY INSPECTION REPORT**

Prepared For: Joe Homebuyer
Concerning: 123 John Street
Chapel Hill NC 27516
Inspected By: Raleigh Inspection Service
Jonathan Goad NCHILB License #2570
Inspection Date: 10/18/2010
Real Estate Agent:

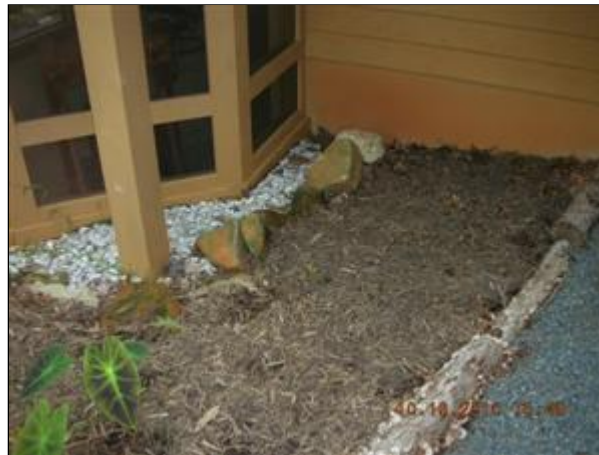
1.2 Picture 1

**Investigate-** *[location: left rear corner at screen porch]* Grade around most of the house is correct, which does enable water to drain away from the homes foundation. **However, negative grade slopes or flat grade slopes were noted at the specified location identified above. It appears a drainage system has been installed. Consulting with current owner is recommended.**

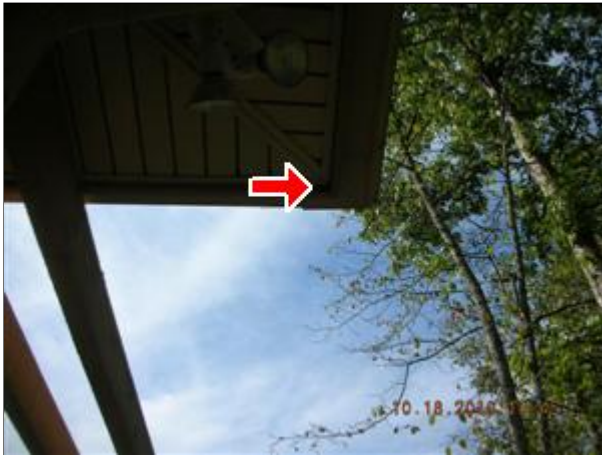
1.9 Picture 1

**Repair-** *[location: front left corner, rear left corner, and right rear corner]* Evidence of moisture present at the bottom lip of the fascia board at the specified location. If these type of issues are not repaired, it could lead to deterioration. A qualified contractor should determine cause and repair. It could be necessary to repair leaky roofing or gutter guards above this location.

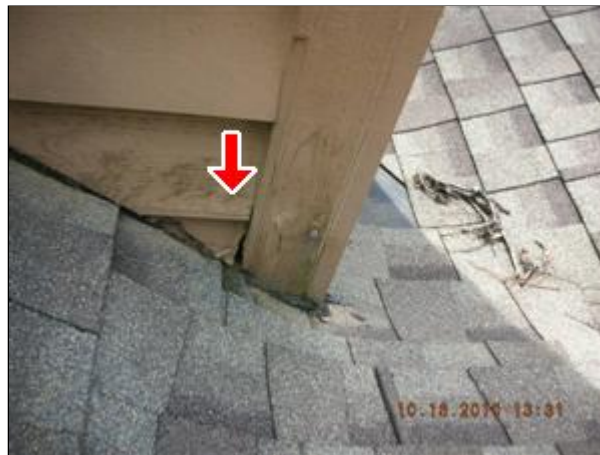
3.3 Picture 1

**Repair-** A section of wall cladding is not securely attached at the back side of the chimney. This section needs to be repaired and sealed.

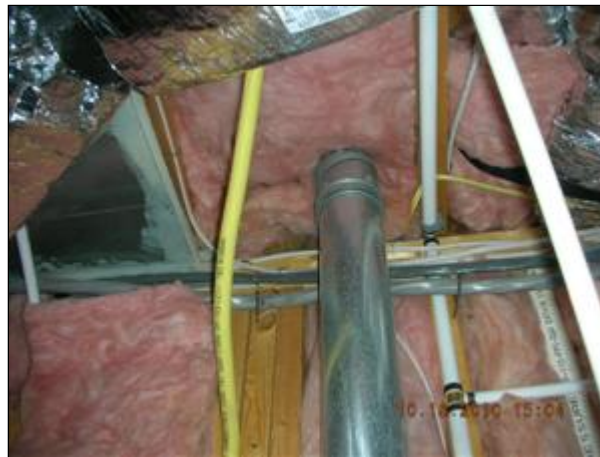
6.8 Picture 1

**Repair-** *[location: basement at]* At least one section of combustible material (insulation and insulation paper) is installed against a metal flue pipe. This condition causes an improper clearance between combustible material and the metal exhaust pipe. Current standards require a two inch clearance between the combustible material and the flue pipe. If possible, installing a metal sleeve allowing for proper clearances is recommended. Removal of combustible material is also acceptable.

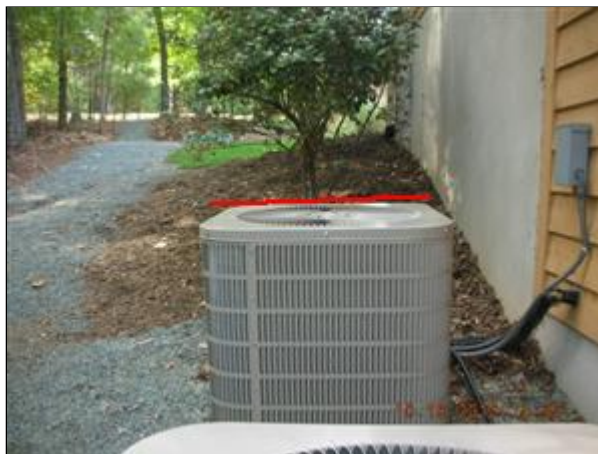
7.5 Picture 1

**Repair-** One condensing unit is not on a level surface. This condition can have a long term negative impact on the performance of the unit. The inspector recommends leveling the pad the unit rests on.
