Inspection Report

Property Address:
123 John Street
Somewhere NC 90210

Raleigh Inspection Service

Date: 1/21/2016	Time: 08:30 AM	Report ID: JohnStSAMPLE
Property: 123 John Street Somewhere NC 90210	Customer: John Q Buyer	Real Estate Professional: Ron Realtor

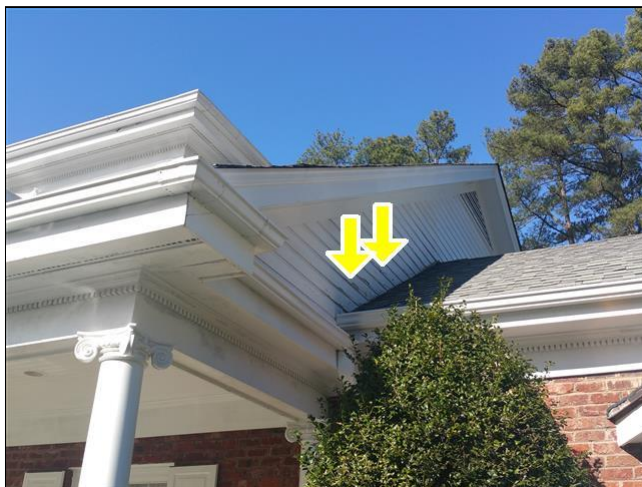
along roof line at front

- 🔧 (1) **Repair-** Exterior trim and wall cladding deterioration (or damage) is present at several locations. A siding contractor should evaluate all exterior sides of the home and repair as necessary. The inspector has provided photographs where deterioration or damage was found. Photographed areas require immediate repair.

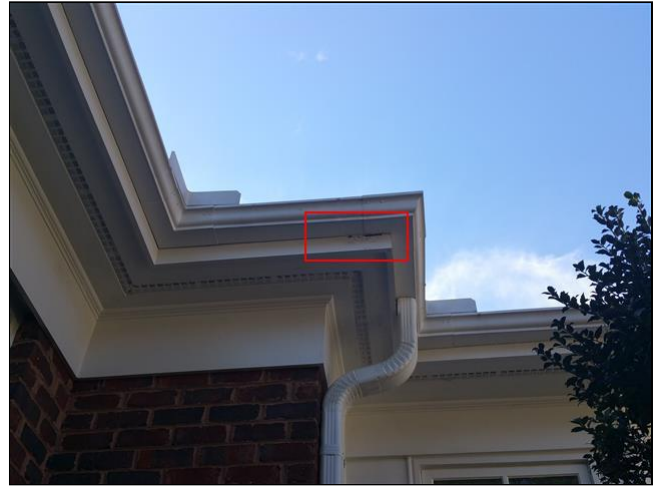
suspected

- 🔧 (3) **Repair-** *[location: rear side of home at porch (or patio)]* The soffit is deteriorated at the specified location. If these type of issues are not repaired, it could lead to moisture intrusion inside the house and other interior framing members. A qualified contractor should determine cause and repair or replace affected wood. It could be necessary to repair leaky roofing above this location.

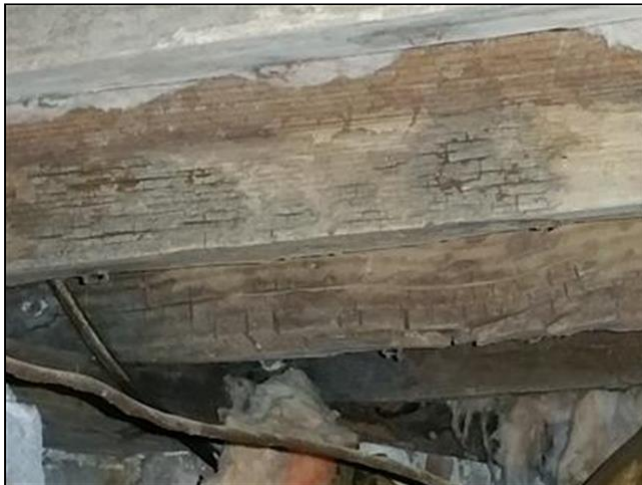
- 🔧 (1) **Repair-** *[location: right crawlspace below kitchen and billiard room]* A section of flooring appears to be sagging with respect to the rest of the floor system. There is evidence that suggest the underfloor area has been exposed to high humidity. The soil was muddy or water logged underneath the vapor barrier. The bottom 1/3 of a floor joist is deteriorated in some areas. Sagging floors were observed along interior spaces. Existing ventilation is poor. Consulting with a ventilation contractor or "closed crawlspace" contractor is recommended. A licensed general contractor should make joist repair per engineers specifications.

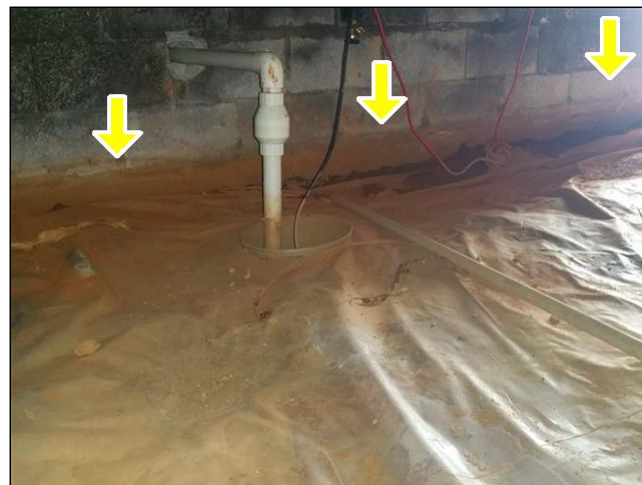
- 🔍 (2) **Investigate-** A moisture control system has been installed within the underfloor areas. Generally, this type of system is installed to reduce the moisture levels within the underfloor area. The subject house contains a sump pump under the front left corner of the house. Current owner should provide more information. The client should consider obtaining opinion from a qualified contractor. Evidence of ponding was observed.

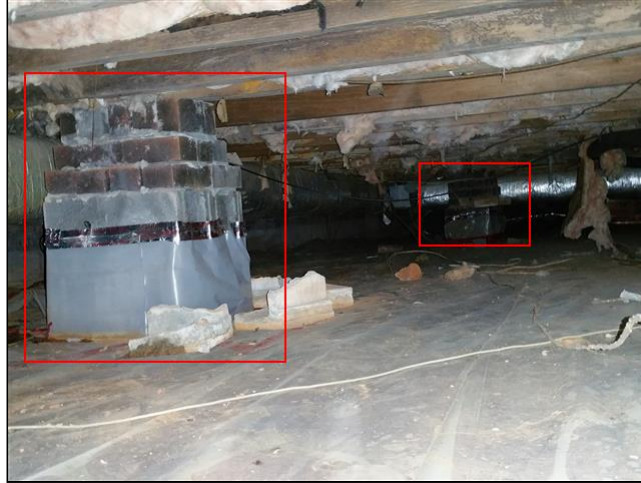
- 🔍 **Investigate-** *[location: behind front porch]* A supplemental point load support system has been installed under the original floor framing since the house was originally built. To insure long term stability, these systems should be installed on poured concrete footers. These types of systems are often put into place to provide additional support to the loads directly above. This type of system is very common in older homes, remodeling jobs, piano installations, and any other instance when additional loads are being added to the original floor system. Current owner should provide more information. Purpose of these piers is unknown. Review by licensed engineer is recommended.

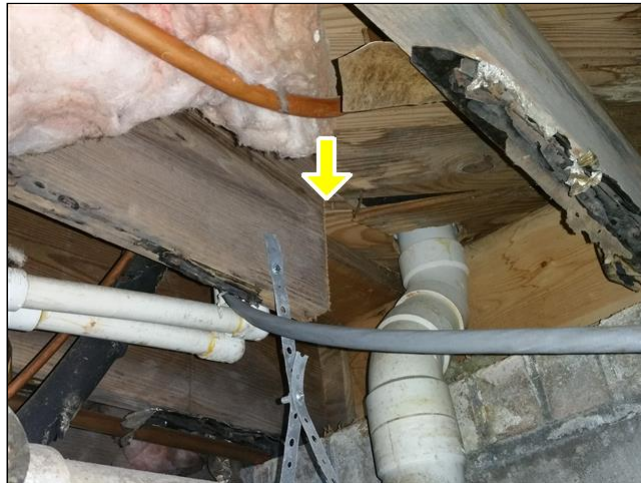
- 🔍 **Repair-** *[location: under the first floor half bathroom]* A floor joist is improperly cut in the underfloor area. Often floor systems are improperly cut so that plumbing pipes can be placed at specific location within the room above. The floor system is a very important part of a homes structural integrity. A licensed general contractor should repair.

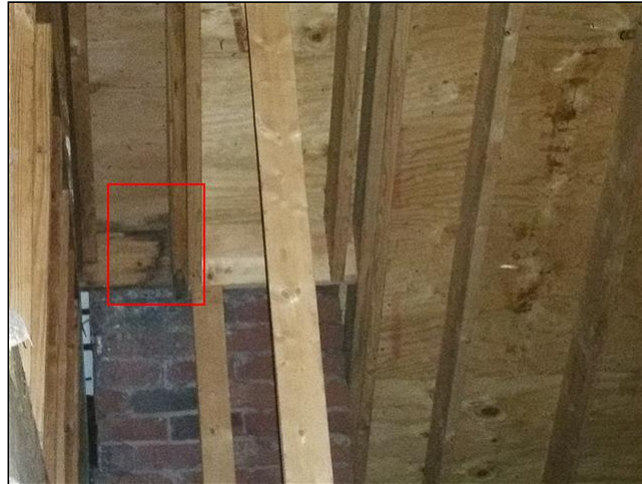
- 🔍 (2) **Investigate-** Water intrusion stains were observed on the surrounding area where the chimney joins the roof sheathing. The inspector is unable to determine if this is recent water intrusion. A roofing contractor should provide opinion.

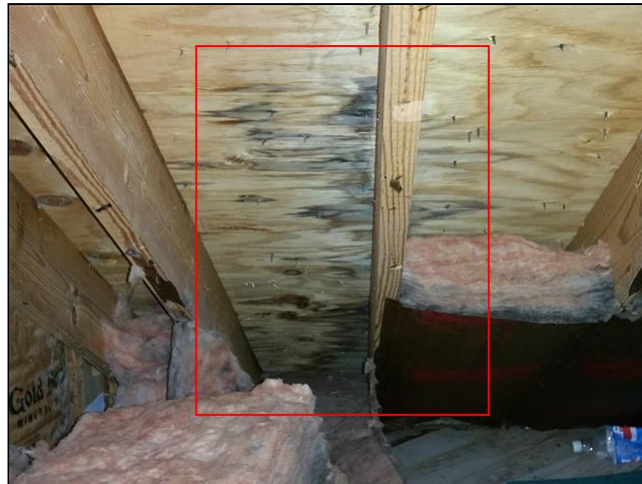
- 🔍 (3) **Investigate-** *[location: front left roof pitch]* Water intrusion intrusion stains were observed on the OSB sheathing in the attic. The inspector is unable to determine, with certainty, if the stains are from past or present leakage. A roofing contractor should provide opinion.

The inspector observed more than 3 stain(s).

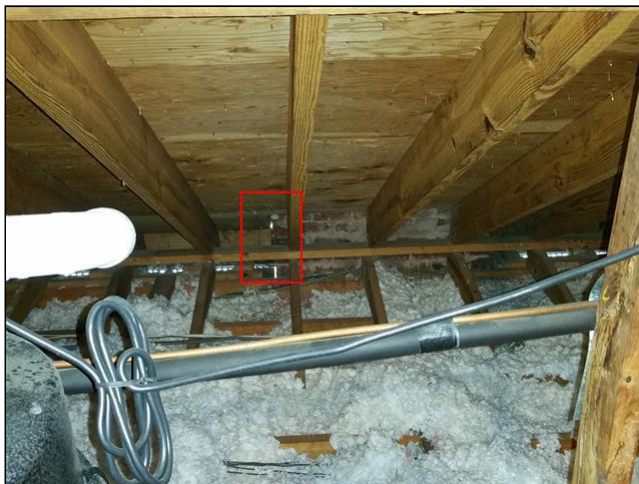
**Repair-** *[location: around the rear chimney]* While inspecting the attic space, the inspector observed daylight at a pipe penetration. This condition generally indicates that the pipe and/or flue penetrations need additional sealant or flashing maintenance. Moisture can intrude if not repaired.

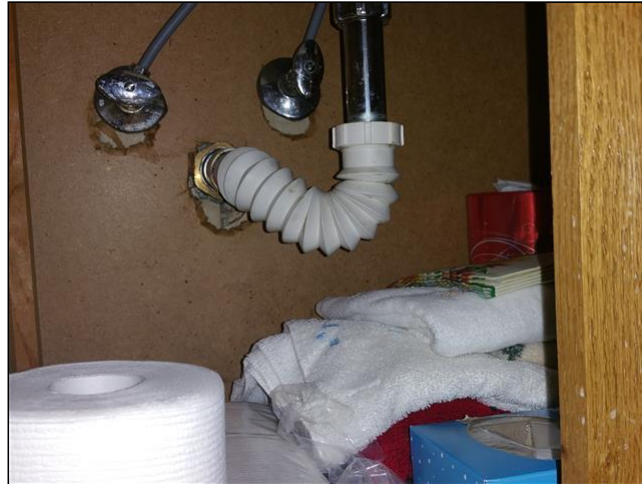
- 🔧 (2) **Repair-** *[location: first floor rear right half bathroom]* A trap seal is required to be at least 2 inches and no more than 4 inches in depth. An improper seal could cause siphoning or sludge in the plumbing system. Repair is recommended at the specified location.

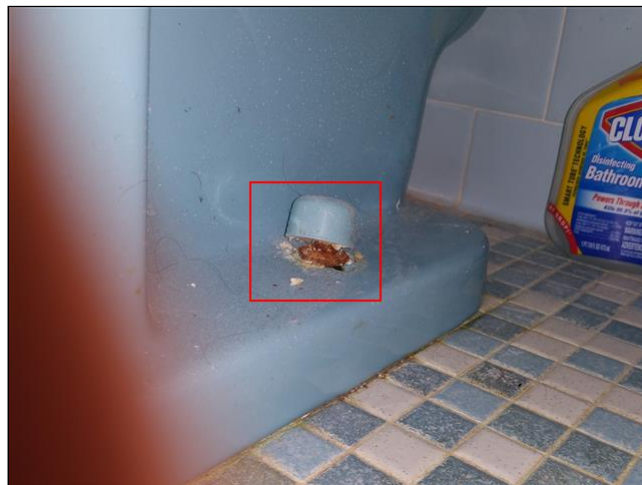
- 🔧 (1) **Repair-** *[location: second floor guest bathroom]* The toilet may be leaking at the wax ring where the toilet transitions to the waste pipe. The bolts that mount the toilet to the floor are corroded. This generally indicates the wax ring is failed. Sometimes the wax ring at the toilet floor connection can leak gradually over time. A licensed plumbing contractor should repair.

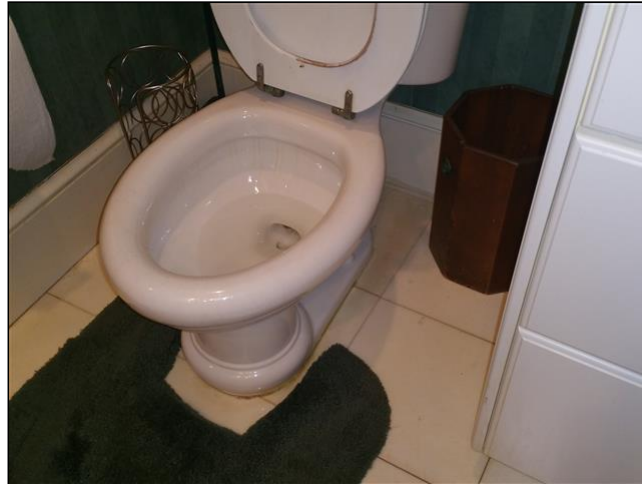
- 🔧 (2) **Repair-** *[location: master bathroom]* The toilet may be leaking at the wax ring where the toilet transitions to the waste pipe. Moisture stains were observed at finished floors at the base of the toilet. Sometimes the wax ring at the toilet floor connection can leak gradually over time. A licensed plumbing contractor should repair.

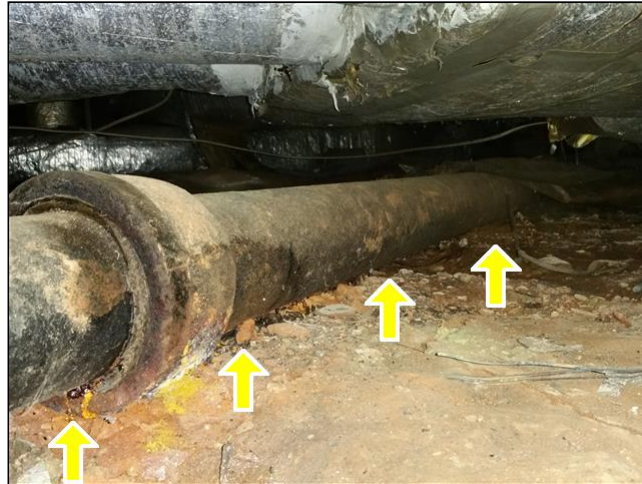
**Repair-** *[location: under the rear right crawlspace]* A drain or waste line shows signs of recent leakage. A crack on the bottom side of drain pipe was noted. A plumbing contractor should examine to determine necessary repairs. The inspector recommends consulting a licensed plumbing contractor to determine cause and repair as needed.

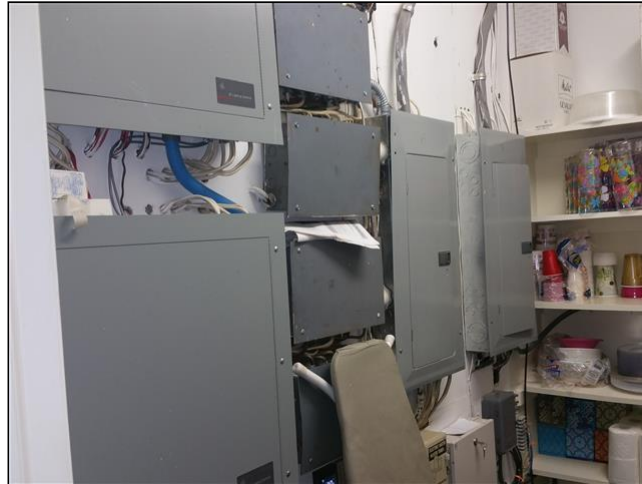
- 🔍 (2) **Investigate-** The inspection of the main panel box revealed at least one unusual wiring configuration that is unfamiliar to the inspector. A total of SEVEN distribution panels were observed. The inspector recommends consulting a licensed electrician for complete review of electrical system.

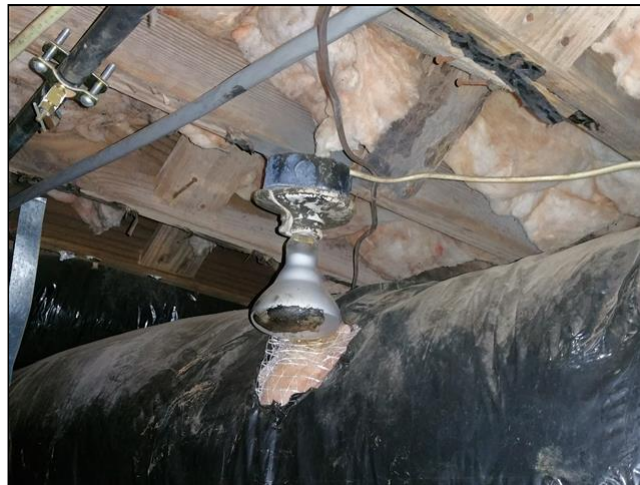
- 🔧 (1) **Repair-** *[location: near furnace at center of crawlspace]* An electrical lighting device is damaged. This condition is considered a fire hazard.

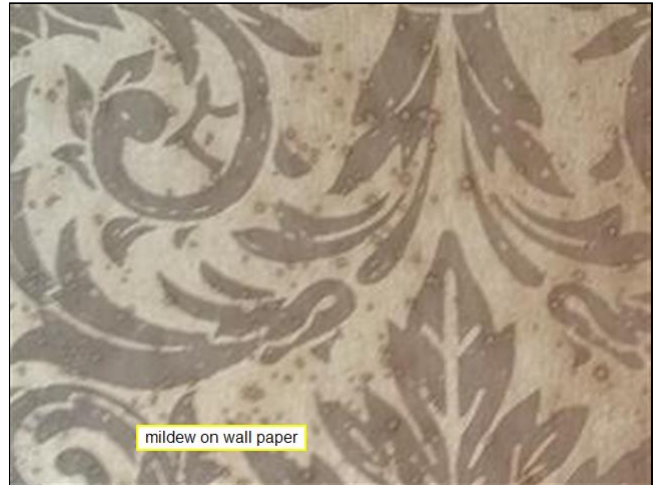
humidity evidence/mold on wall

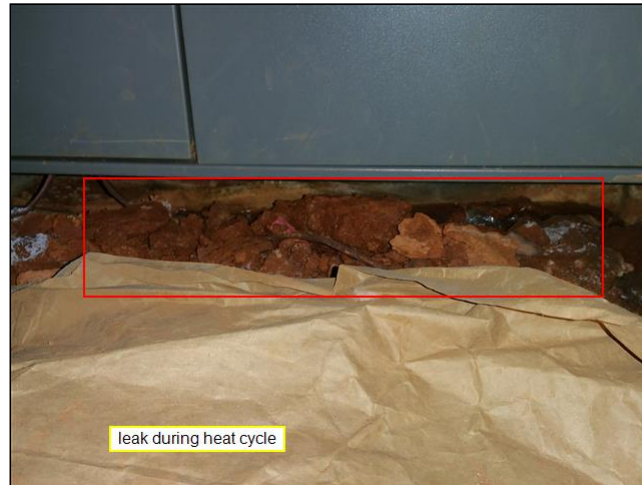
- 🔧 (2) **Repair-** *[location: center crawlspace]* The combustion condensate drain line originating at the furnace does not drain all excess condensation properly. There is evidence that suggest the line has leaked moisture recently.

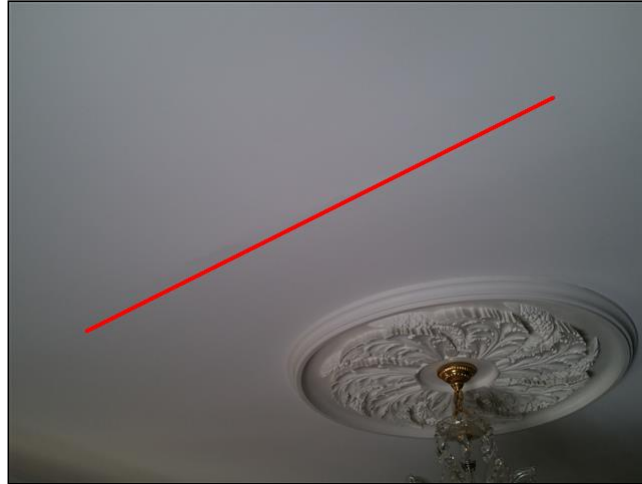
- 🔍 (2) **Investigate/Repair** [location: *dining room*] The interior ceiling is cracking or de-laminating . Cause is unknown. The client should consider obtaining opinion from a qualified contractor.

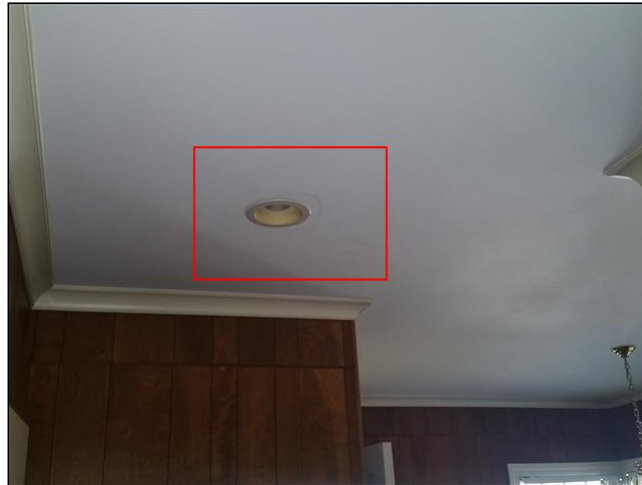
- 🔍 (3) **Investigate-** [location: *kitchen*] The interior ceiling shows stains which could indicate exterior water intrusion or a leaking or sweating condensation line. The inspector is unable to determine with certainty if the stain is the result of a past incident or present problem. Current owner should provide more information. A qualified contractor should provide opinion.

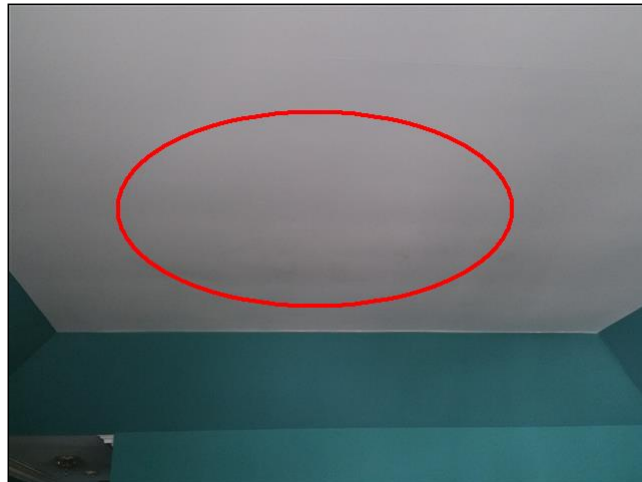
- 🔍 (4) **Investigate-** [location: *master bedroom*] The interior ceiling shows stains which could indicate a roof leak. The inspector is unable to determine with certainty if the stain is the result of a past incident or present problem. Current owner should provide more information. A roofing contractor should provide opinion.

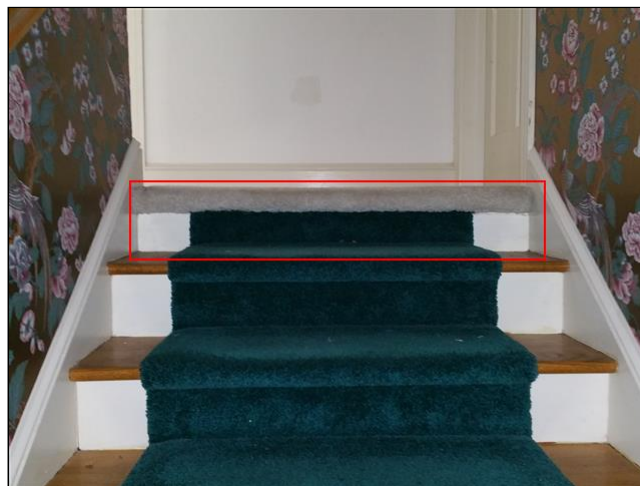
🔧 **Repair-** [*stairway leading to the second floor*] At least one inconsistent stair riser height was noted at the interior stairs. All stair risers should have a consistent height from top to bottom (allowing for 3/8 inch differential). This condition is considered a tripping hazard and should be corrected.

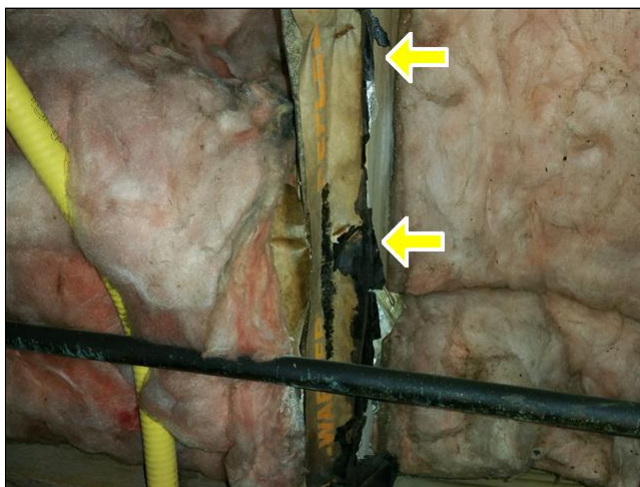
- 🔍 (4) **Investigate-** *[location: crawlspace]* Soot stains were observed at the specified location. This could indicate a fire has occurred at the subject property. Framing members are still solid. Further investigation is necessary to gain historical prospective about the property. Consulting the current owner and an insurance provider is recommended.

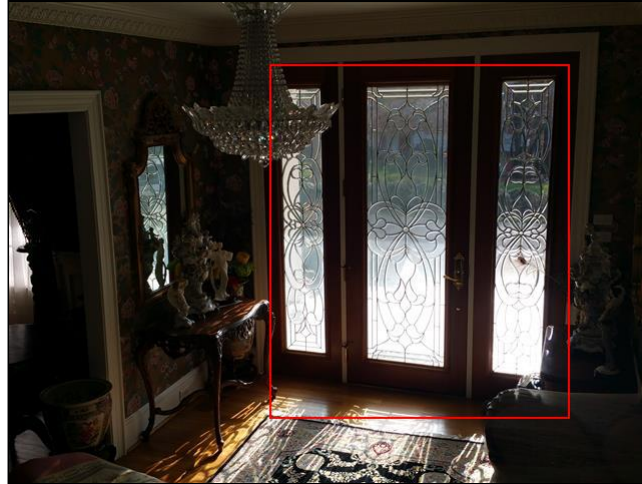
- 🔧 (1) **Repair-** *[location: front entry door]* The seals on a thermal pane window in the specified location are damaged. Damaged seals can allow moisture in between glass panes. This window currently shows condensation in between the glass panes. The inspector recommends repairing identified windows. To insure all damaged thermal seals were identified, a window contractor should check every window in the house to determine if additional thermal seals need repair.

Number of windows in this area that are damaged= 3

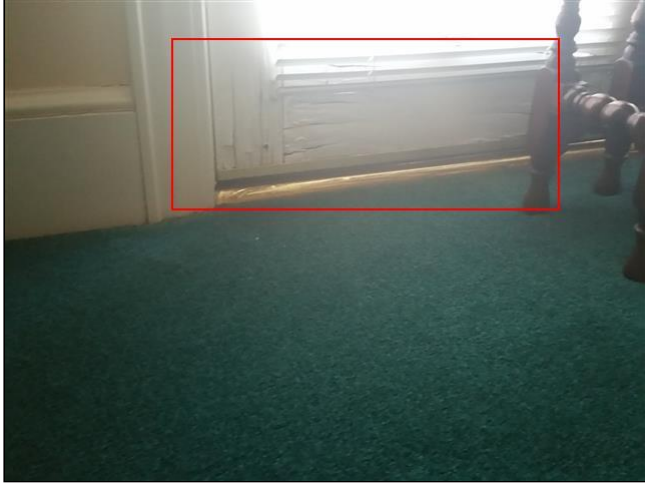
- 4. Repair-** *[location: rear entry door]* The door at the specified location is damaged or deteriorated. A common location for door deterioration is at the bottom of the door. A qualified contractor should examine the door and repair as necessary. Full door replacement may be necessary.

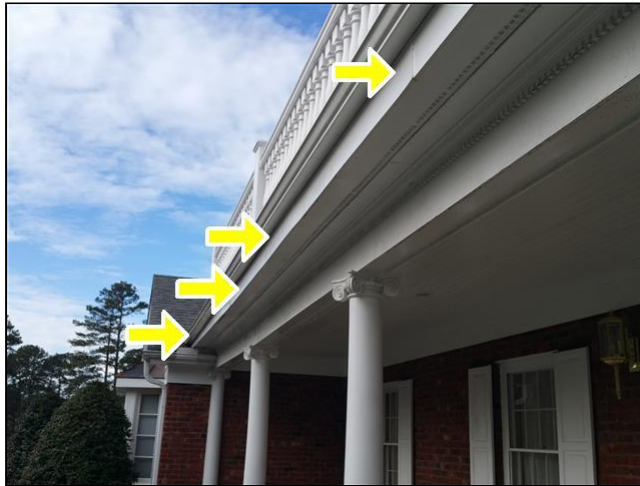
- 5. (1) Repair-** *[location: along soffit at front porch (or patio)]* Rusty nail heads are present on the bottom side of a boxed soffit. This condition generally indicates moisture has intruded at roof covering directly above. Gutters are not functioning properly. Drip edge installation may be necessary. Soffit damage was observed. This roof area above the soffit should be examined by a roofing contractor and repaired where necessary. Licensed general contractor should repair.

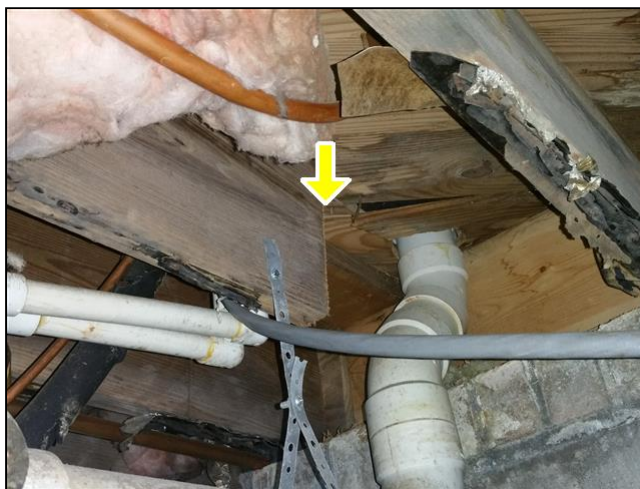
- 9. Repair-** *[location: under the first floor half bathroom]* A floor joist is improperly cut in the underfloor area. Often floor systems are improperly cut so that plumbing pipes can be placed at specific location within the room above. The floor system is a very important part of a homes structural integrity. A licensed general contractor should repair.

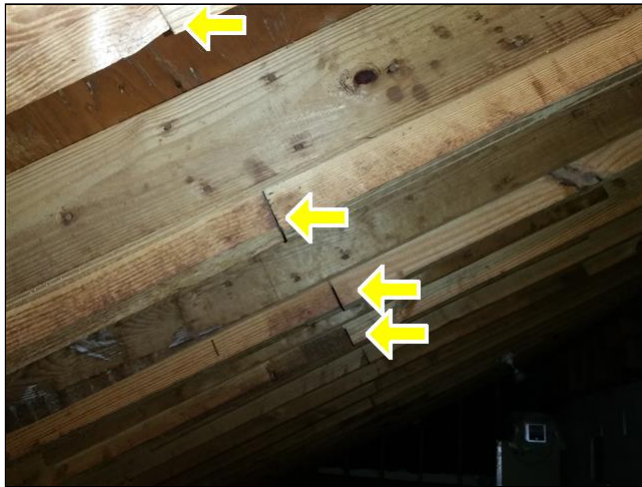
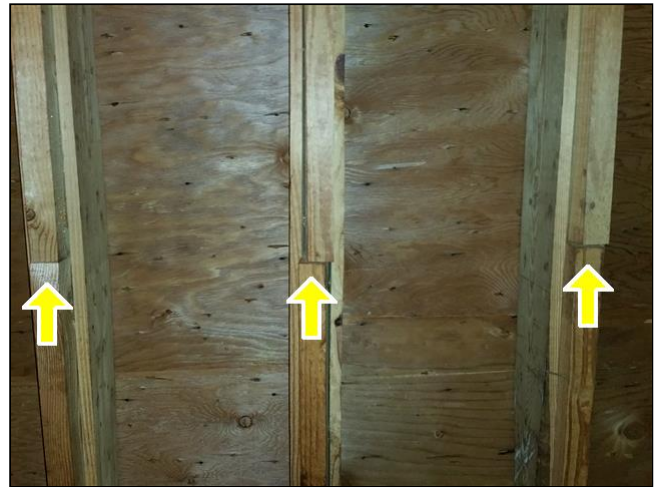
- 10. Investigate/Repair** *[location: area at rear portion of attic space]* The rear set of rafters are cut at mid span. A temporary repair has been made. The roof rafter system should be designed and constructed in compliance with the building code. Building standards have changed since this house was originally constructed. Materials used should be spaced, sized, and span according to lumber manufacturers specifications. The inspector identified a location where spacing, sizing, or

span may require improvements or reinforcement. A licensed structural engineer should evaluate and make recommendations.

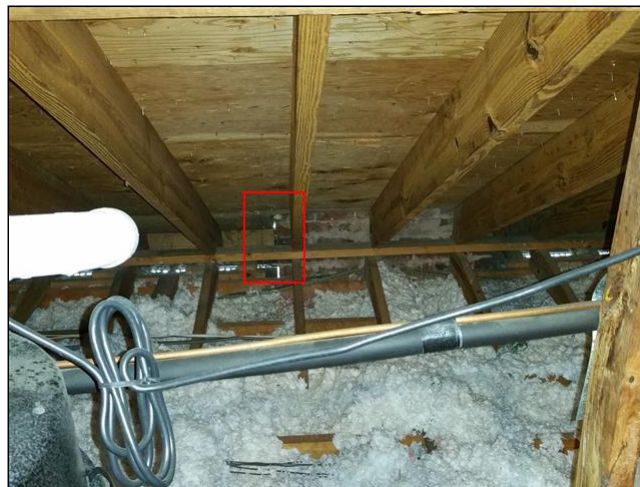
- 11. Repair-** *[location: around the rear chimney]* While inspecting the attic space, the inspector observed daylight at a pipe penetration. This condition generally indicates that the pipe and/or flue penetrations need additional sealant or flashing maintenance. Moisture can intrude if not repaired.

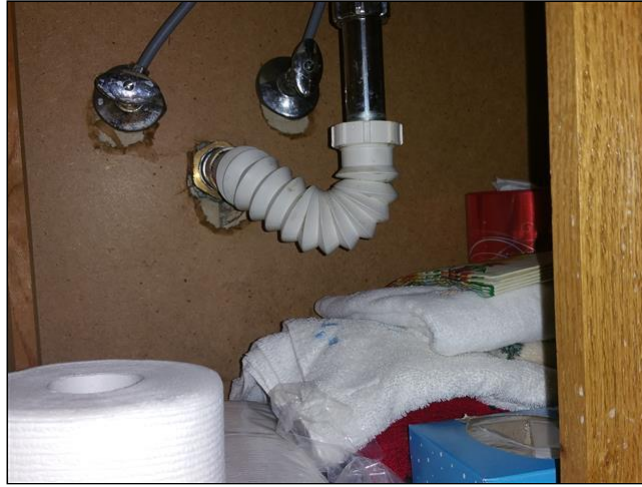
- 12. (1) Repair-** *[location: second floor guest bathroom]* A drain stopper was activated, but did not maintain a constant water level for at least two minutes. Specifically, the tub drain stopper does not function as intended in the specified location.
- 13. (2) Repair-** *[location: first floor rear right half bathroom]* A trap seal is required to be at least 2 inches and no more than 4 inches in depth. An improper seal could cause siphoning or sludge in the plumbing system. Repair is recommended at the specified location.

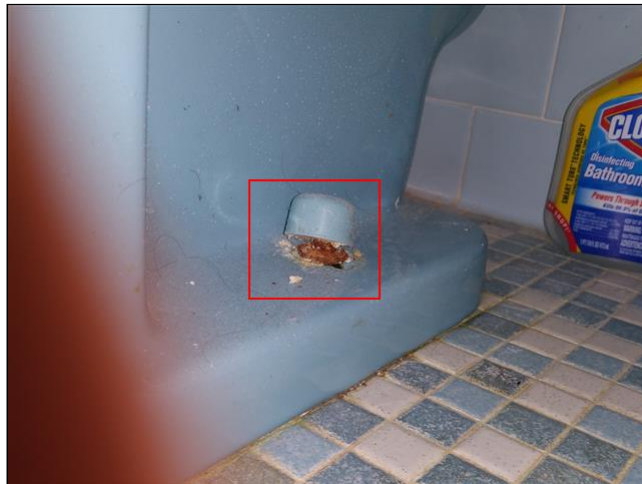
16. (1) **Repair-** *[location: second floor guest bathroom]* The toilet may be leaking at the wax ring where the toilet transitions to the waste pipe. The bolts that mount the toilet to the floor are corroded. This generally indicates the wax ring is failed. Sometimes the wax ring at the toilet floor connection can leak gradually over time. A licensed plumbing contractor should repair.

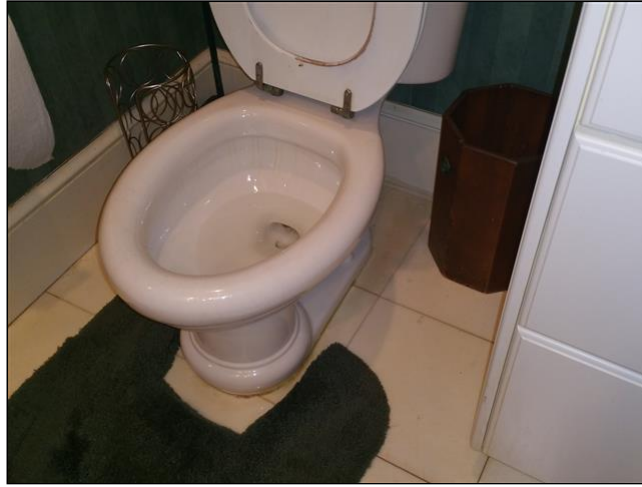
17. (2) **Repair-** *[location: master bathroom]* The toilet may be leaking at the wax ring where the toilet transitions to the waste pipe. Moisture stains were observed at finished floors at the base of the toilet. Sometimes the wax ring at the toilet floor connection can leak gradually over time. A licensed plumbing contractor should repair.

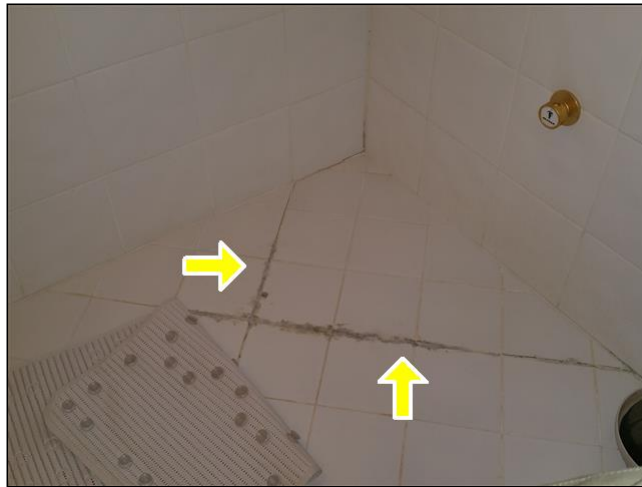
18. (2) **Repair-** *[location: master bathroom]* The ceramic tile near the tub/shower is severely cracked and has been temporarily repaired. Additional repairs are necessary. Performing shower pan test is recommended.

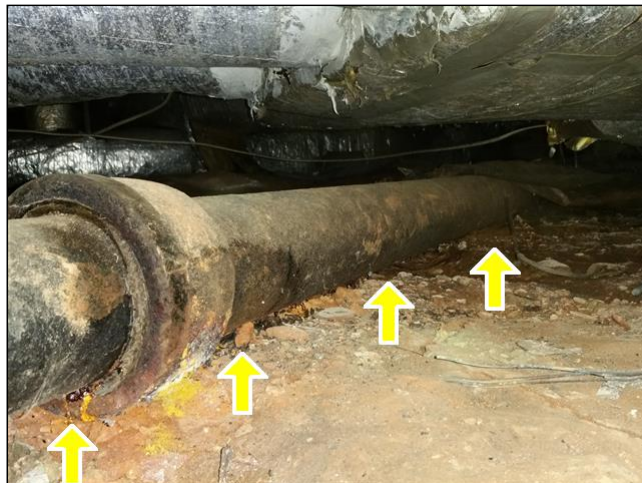
19. **Repair-** *[location: under the rear right crawlspace]* A drain or waste line shows signs of recent leakage. A crack on the bottom side of drain pipe was noted. A plumbing contractor should examine to determine necessary repairs. The inspector recommends consulting a licensed plumbing contractor to determine cause and repair as needed.

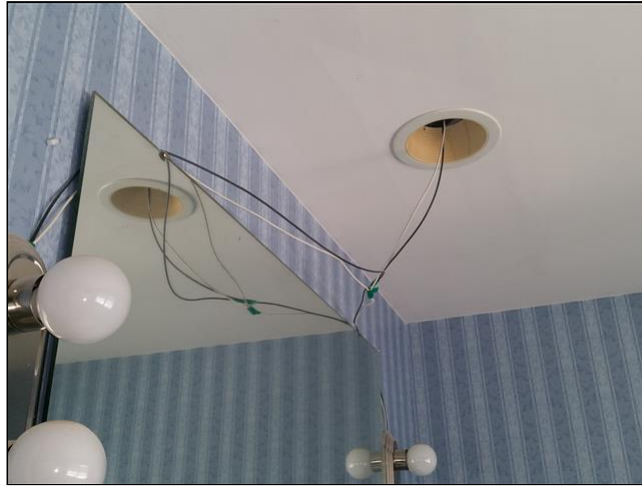
22. (1) **Repair-** *[location: second floor guest bathroom]* An extension cord is used to power an permanently installed electrical device. A licensed electrical contractor should connect the device with a permanent branch circuit.

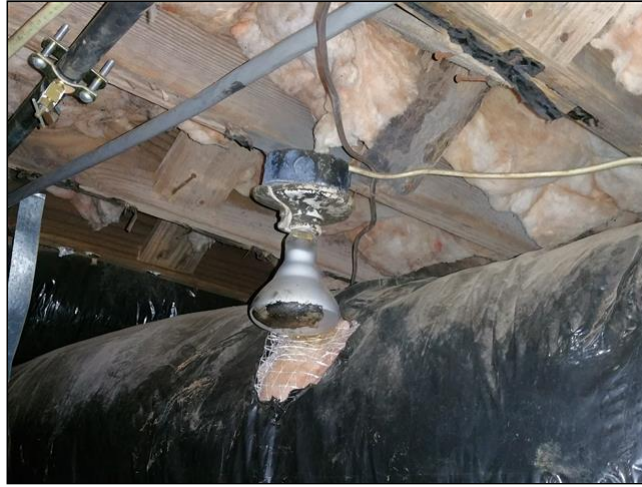
24. (1) **Repair-** *[location: near furnace at center of crawlspace]* An electrical lighting device is damaged. This condition is considered a fire hazard.

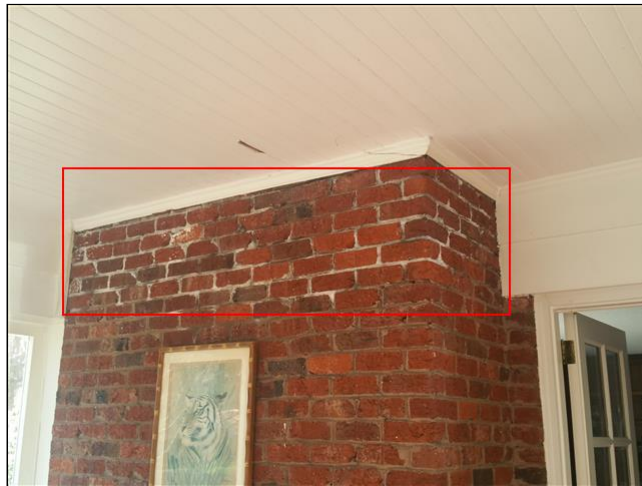
- 27. (3) Investigate/Repair-** *[location: right porch (or patio)]* The inspector observed efflorescence or white mineral deposits that could indicate previous water intrusion from the chimney cap. This condition generally indicates that the pipe and/or flue penetrations need additional sealant or flashing maintenance. Contractor should investigate and repair as necessary.

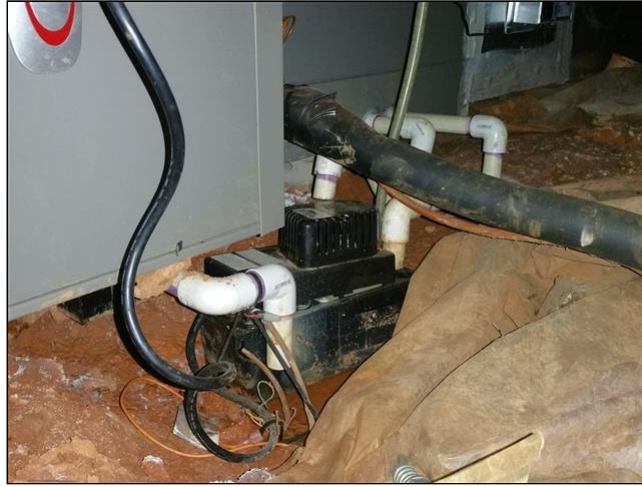
- 29. (1) Repair-** *[location: unit in the center crawlspace]* The condensation drain line is not functioning as intended. Currently, all excess condensation is draining into crawlspace. It appears the condensate pump/drain was never installed correctly. If left uncorrected, this defect could cause excessive moisture levels in the crawlspace. The inspector recommends consulting a licensed HVAC contractor for repair.

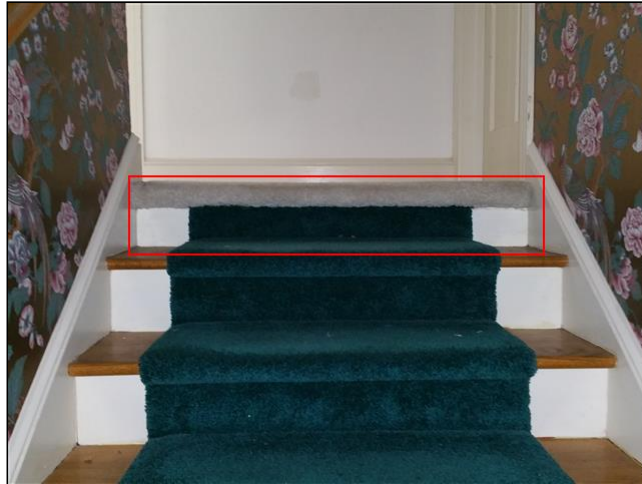
- 32. Repair-** *[stairway leading to the second floor]* At least one inconsistent stair riser height was noted at the interior stairs. All stair risers should have a consistent height from top to bottom (allowing for 3/8 inch differential). This condition is considered a tripping hazard and should be corrected.

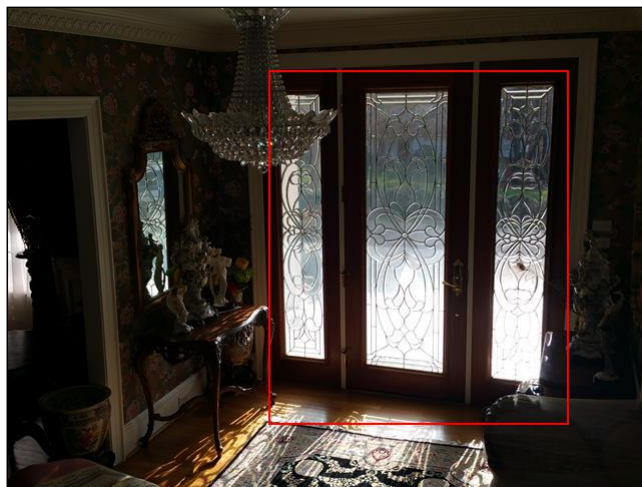
- 35. (1) Repair-** *[location: front entry door]* The seals on a thermal pane window in the specified location are damaged. Damaged seals can allow moisture in between glass panes. This window currently shows condensation in between the glass panes. The inspector recommends repairing identified windows. To insure all damaged thermal seals were identified, a window contractor should check every window in the house to determine if additional thermal seals need repair.

Number of windows in this area that are damaged= 3

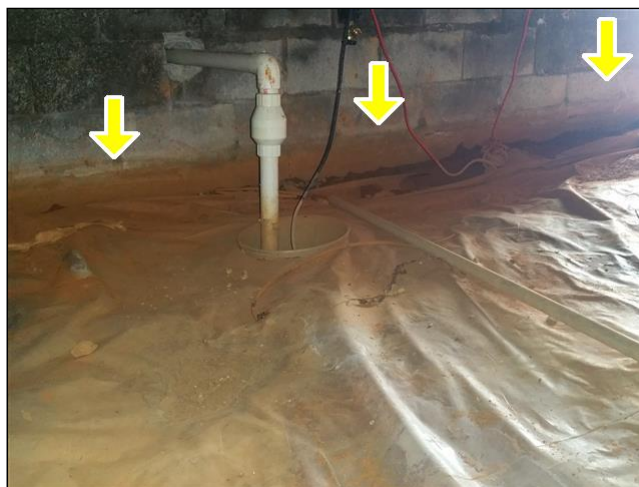
- 37. (2) Investigate-** A moisture control system has been installed within the underfloor areas. Generally, this type of system is installed to reduce the moisture levels within the underfloor area. The subject house contains a sump pump under the front left corner of the house. Current owner should provide more information. The client should consider obtaining opinion from a qualified contractor. Evidence of ponding was observed.

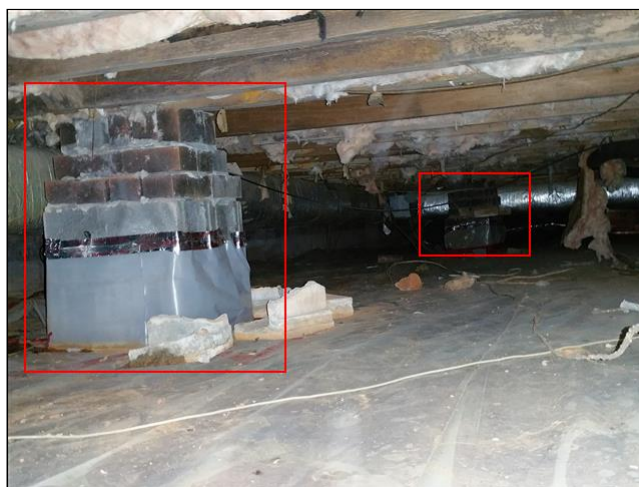
- 38. Investigate-** *[location: behind front porch]* A supplemental point load support system has been installed under the original floor framing since the house was originally built. To insure long term stability, these systems should be installed on poured concrete footers. These types of systems are often put into place to provide additional support to the loads directly above. This type of system is very common in older homes, remodeling jobs, piano installations, and any other instance when additional loads are being added to the original floor system. Current owner should provide more information. Purpose of these piers is unknown. Review by licensed engineer is recommended.

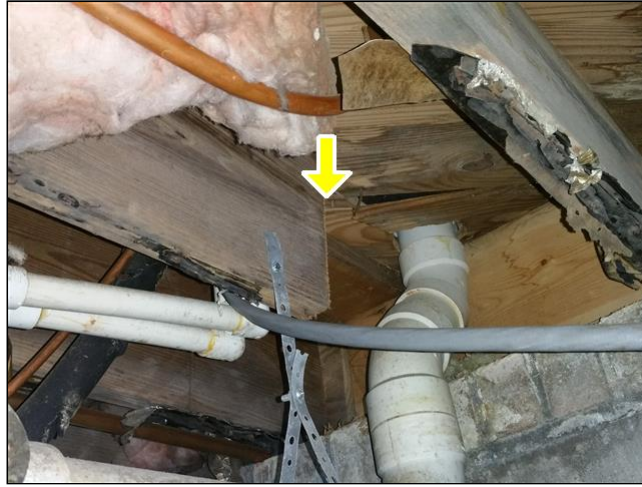
- 39. Repair-** *[location: under the first floor half bathroom]* A floor joist is improperly cut in the underfloor area. Often floor systems are improperly cut so that plumbing pipes can be placed at specific location within the room above. The floor system is a very important part of a homes structural integrity. A licensed general contractor should repair.

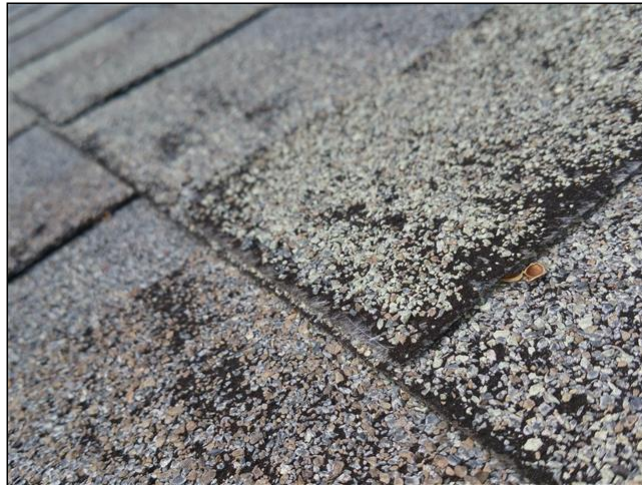
- 40. Investigate-** The roof covering is a architectural asphalt shingle roof system. Most architectural asphalt shingled roof systems that are properly maintained typically yield 20 years on average. The inspector believes the roof covering **is nearing the end of an average roofing life cycle**. Fiberglass mat exposure was observed. Mat exposure and granular loss is indicative of an aging roof covering. The client should consider obtaining opinion from a roofing contractor.

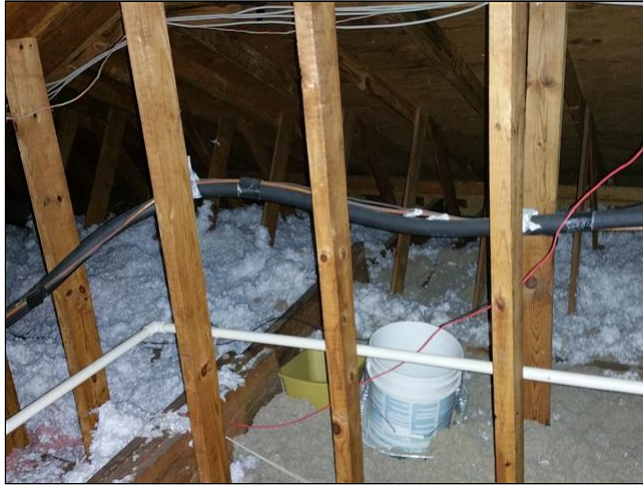
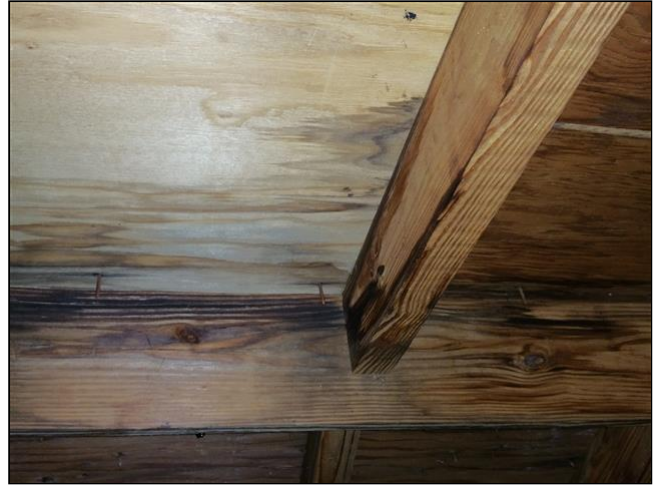
- 41. (1) Investigate-** *[location: along rear right corner roof surface]* While inspecting the attic space, the inspector observed water stains at or near a pipe penetration. This condition generally indicates that the pipe and/or flue penetrations need additional sealant or flashing maintenance. The inspector is unable to determine, with certainty, if the stains are from past or present leakage. A roofing contractor should provide opinion.

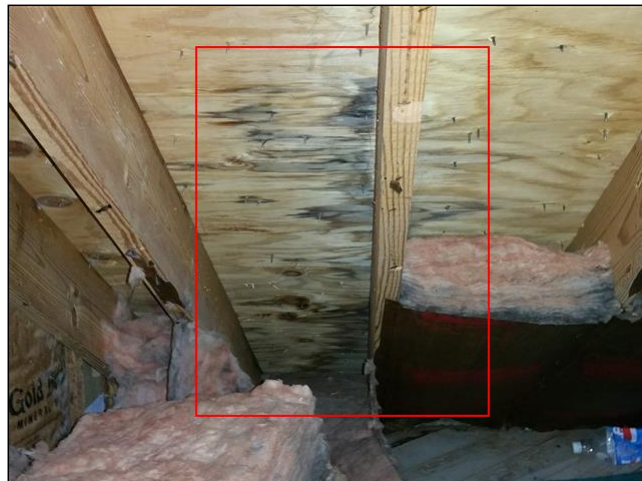
- 43. (3) Investigate-** *[location: front left roof pitch]* Water intrusion intrusion stains were observed on the OSB sheathing in the attic. The inspector is unable to determine, with certainty, if the stains are from past or present leakage. A roofing contractor should provide opinion.

The inspector observed more than 3 stain(s).

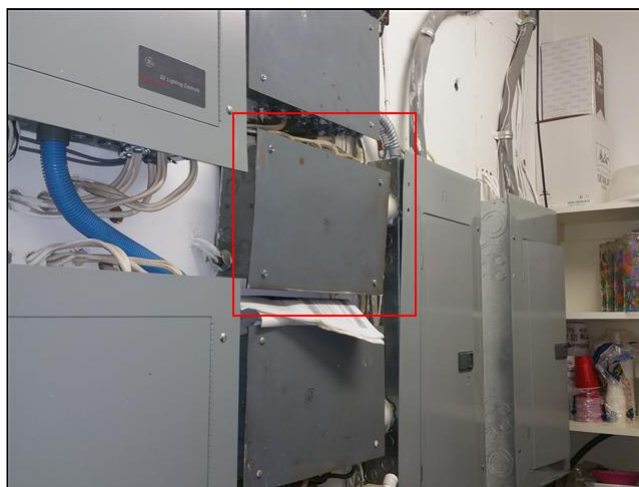
45. (1) **Investigate-** *[location: all distribution boxes]* The cover of the electrical panel was unusually warm. This condition generally indicates a conductor inside the panel box is arcing. The inspector did not remove the electrical panel cover because of safety concerns. A licensed electrician should evaluate.

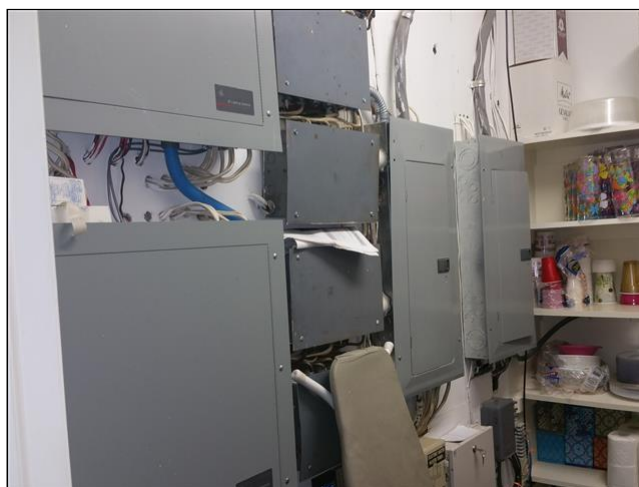
46. (2) **Investigate-** The inspection of the main panel box revealed at least one unusual wiring configuration that is unfamiliar to the inspector. A total of SEVEN distribution panels were observed. The inspector recommends consulting a licensed electrician for complete review of electrical system.

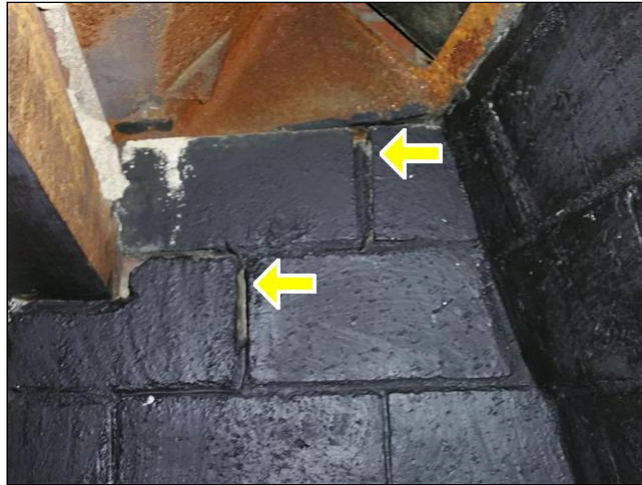
49. (1) **Investigate-** A void or gap was observed between the brick joints inside the formal living room firebox. This condition commonly occurs where the firebox transitions to the clay flue liner. This condition should be checked by a licensed chimney sweep before using the masonry fireplace. Repairs could be necessary.

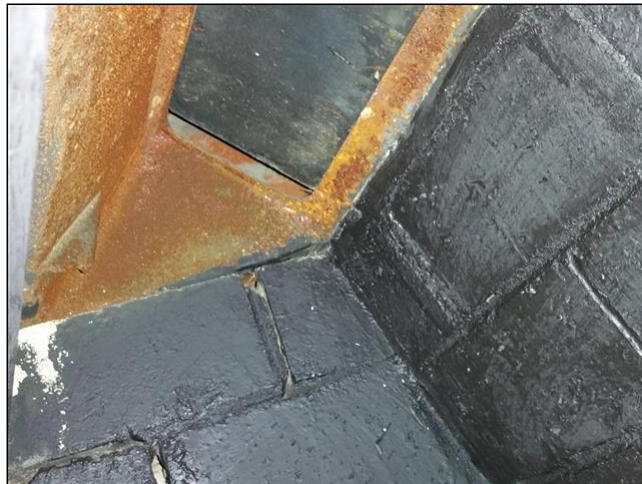
50. (2) **Investigate/Repair-** *[location: formal living room firebox]* While inspecting the fire box, the inspector observed stains that could indicate previous water intrusion from the chimney cap. This condition generally indicates that the pipe and/or flue penetrations need additional sealant or flashing maintenance. Contractor should investigate and repair as necessary.

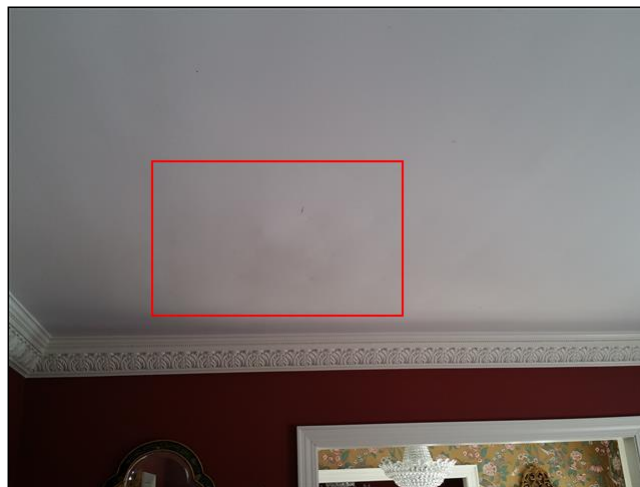
- 54. (1) Investigate/Repair** *[location: formal living room below guest bathroom]* The interior ceiling shows stains which could indicate a plumbing leak. The inspector suspects staining is from a recent event. A licensed plumbing contractor should repair.

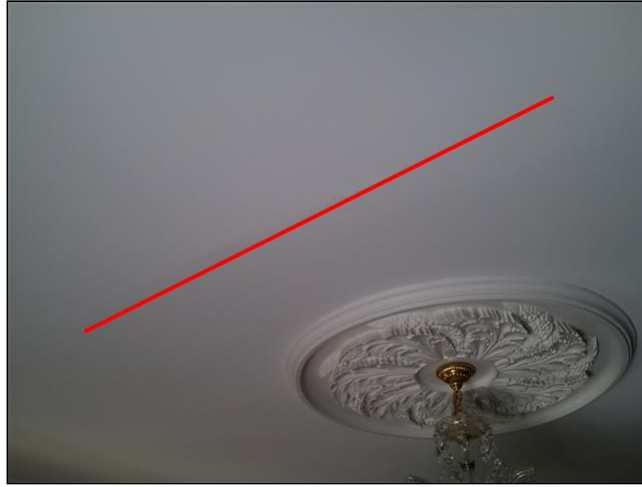
- 55. (2) Investigate/Repair** *[location: dining room]* The interior ceiling is cracking or de-laminating . Cause is unknown. The client should consider obtaining opinion from a qualified contractor.

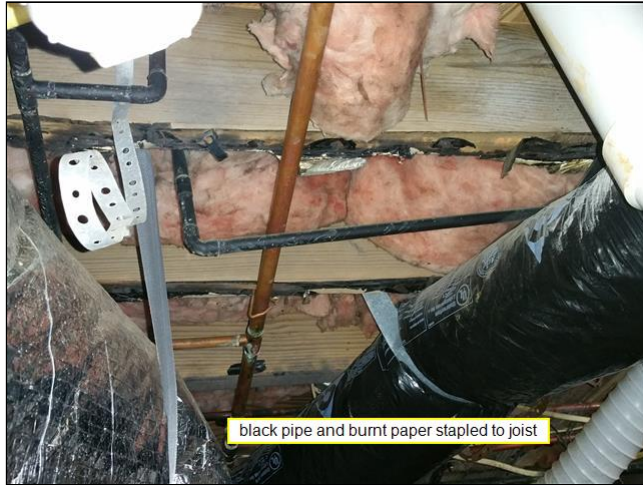
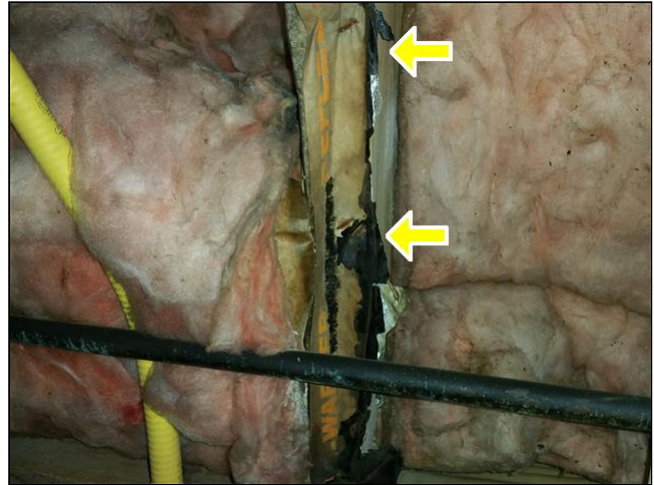
59. (4) **Investigate-** *[location: crawlspace]* Soot stains were observed at the specified location. This could indicate a fire has occurred at the subject property. Framing members are still solid. Further investigation is necessary to gain historical prospective about the property. Consulting the current owner and an insurance provider is recommended.
